## Fire, Cause & Origin of Heavy Vehicles: Mechanical & Forensic Methods

FIRE INVESTIGATION

BY CHRISTOPHER W. FERRONE

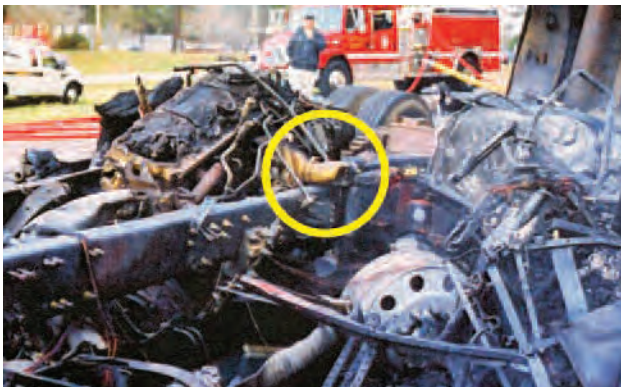
Photo 5: (right)  
Turbocharger with  
impact damage.

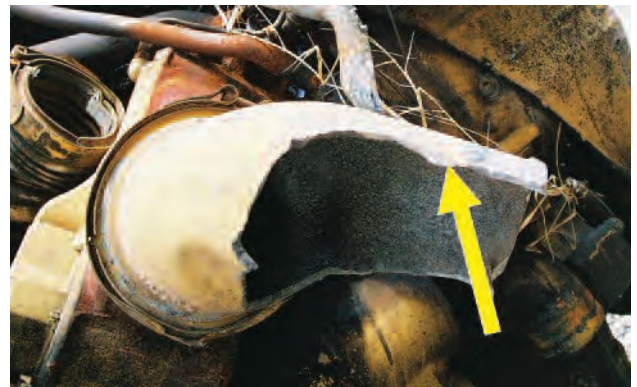
Photo 6:  
(far right)  
Turbocharger with  
impact damage  
showing  
rough edges.

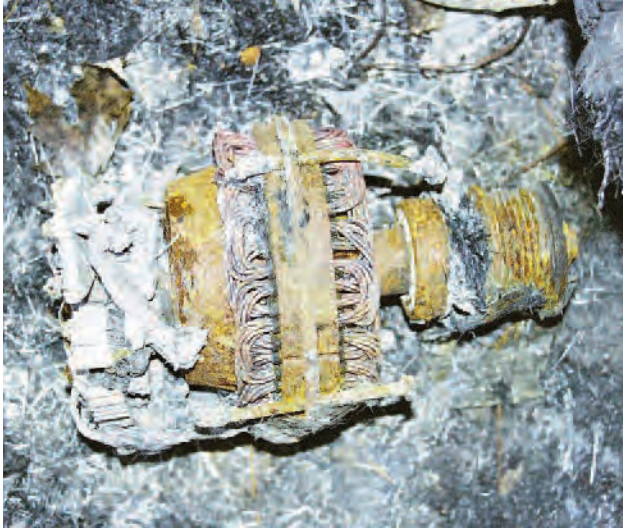
Photo 7: Causal alternator.

In some instances, a fire has begun with the vehicle's engine off and after some period of time since the most recent engine shutdown. This can be attributed to an internal alternator failure, in some instances a diode failure. Diodes act as a one-way check valve for current. Typically, if a diode fails in this scenario, positive (B+) battery voltage/current goes to ground and has been known to start a fire (Photos 7, 8 and 9).

Photo 7 shows an alternator that was determined to be the cause of this fire. Photograph 10 shows the alternator of a truck parked next to the truck in Photo 7, however, with completely different appearances despite being involved in the same fire only a few feet apart.

The alternator in Photo 7 was found on the ground next to the truck. When it was picked up, it had created an unburned area on the floor. This indicates that it fell to the ground before anything else fell on that spot and covered the floor in that area. The solution to this potential fire scenario is to park the truck with the main battery switch off. This will disconnect the batteries from the alternator eliminating this potential.

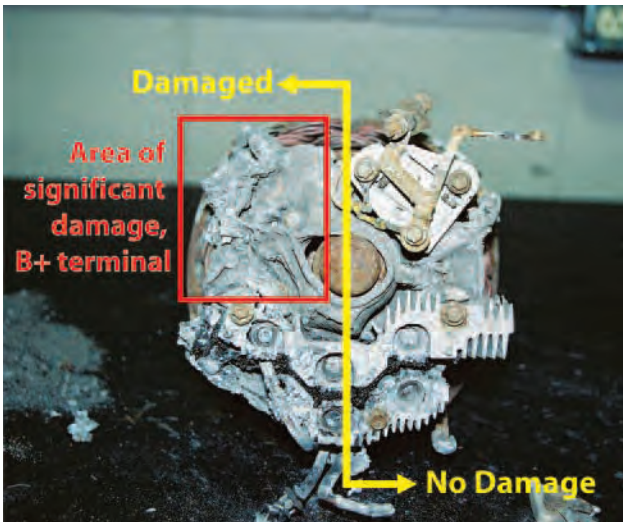
Photo 8: Artifact alternator.

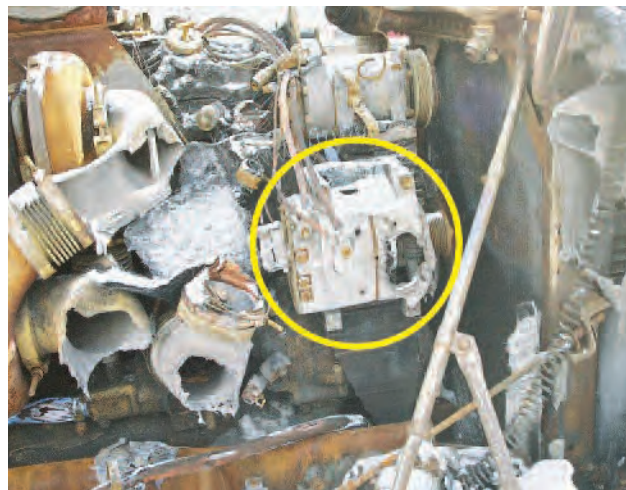
Photo 10: Noncausal alternator.

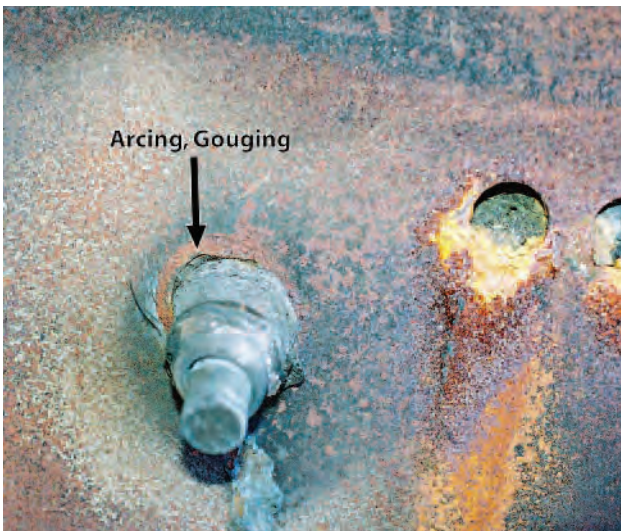
This boot must be in good condition and over the positive (+) stud at all times. A loose jumping stud/cable, or if it is contacted during a collision, can create a sustained duration high-energy spark (Photo 12).

Photo 12: B+ jump post, battery box.

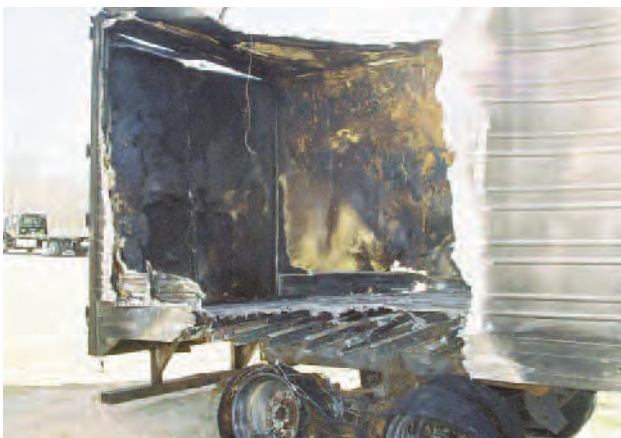
Photo 13: Hub failure/tire fire.

Photo 13 shows a burned trailer, which experienced a hub failure. This failure was caused by low hub oil level. This condition ultimately led to the fire, which started at the tire. This is indicated by the deformed (melted) bearing rollers (Photo 14). Bearing rollers with this appearance can only occur when the hub oil level is low. This deformation cannot occur due to the fire. Low hub oil levels create extremely high heat (Photo 15). The weight of the load that the bearing supports creates pressure on each bearing roller. This pressure coupled with the extreme heat creates the rollers deformation. Once this occurs, the tire(s) near this area can ignite.

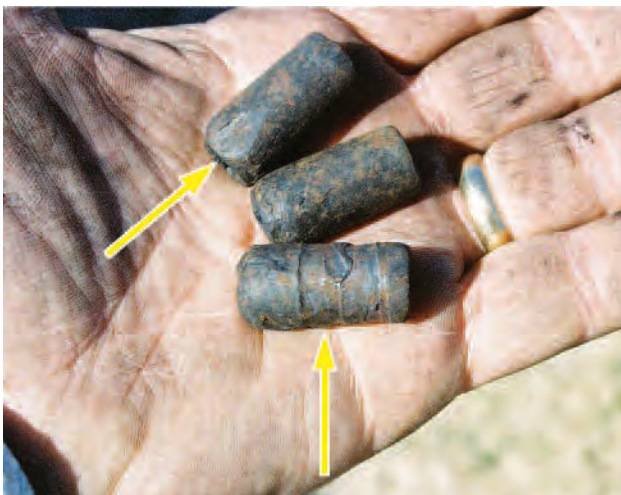
Photo 14: Deformed bearing rollers.

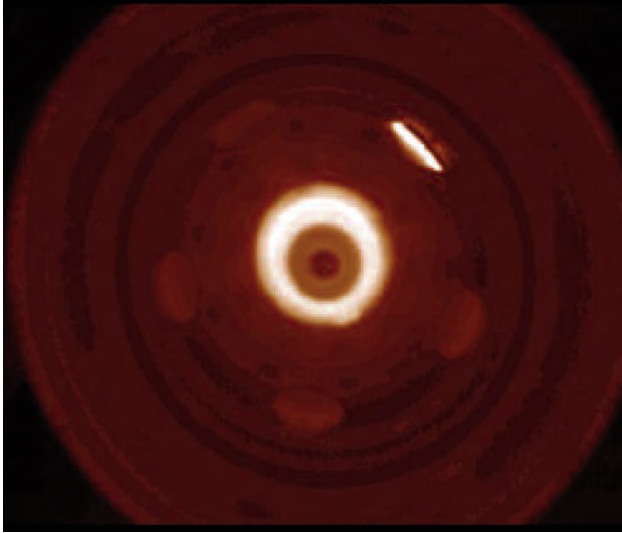
*Photo 15: Thermal scan of an overheated wheel bearing.*

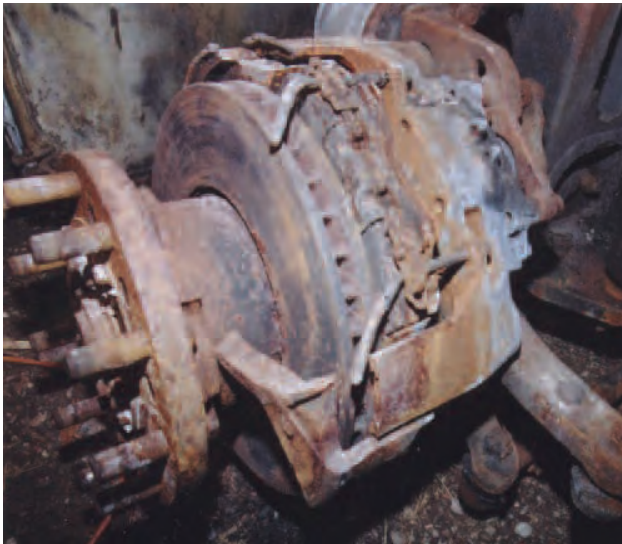
Once the brake caliper begins carrying the load at that particular wheel end, the surface temperature of the brake pads and rotor (or drum) rise well above the auto-ignition temperature of the surrounding combustibles (due to friction) eventually igniting them. The combustible material typically ignited by this failure mode is the tire(s). This concept of brake caliper/pad/rotor supporting the hub load can typically be seen by nonparallel brake pad contact surfaces. As a result of this temporary load support from the caliper, the operator may continue to drive the vehicle without any indication of a problem until it is too late.

*Photo 16: Causal disc brake/wheel end failure.*

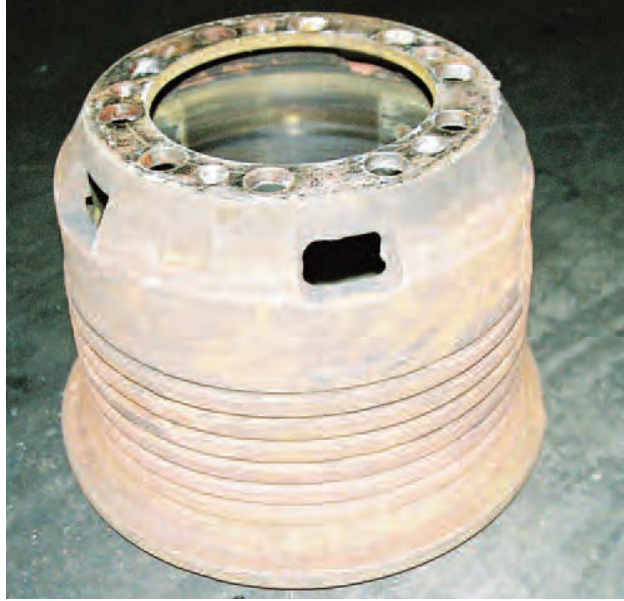
Various pneumatic and mechanical issues can prompt a brake failure, which can lead to a fire. Generally speaking, when drum brakes approach this scenario, they leave signatures. Brake drums may show signs of rouging (Photo 20), and the matching brake blocks may show a burn pattern if not damaged by the fire (Photo 21). In the extreme case, the brake blocks can become fused to the drum as a result of the bonding agent (resin) of the brake blocks actually beginning to melt and burn (Photo 22).

Photo 20: Brake drum rouging caused by overheating.

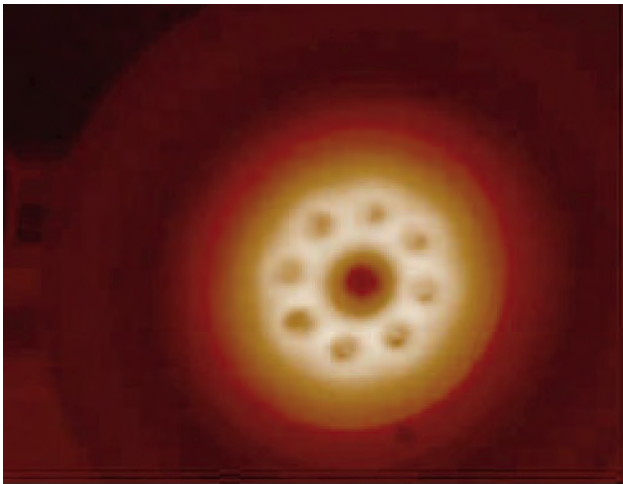
Photo 18: Thermal scan of overheated brake drum.

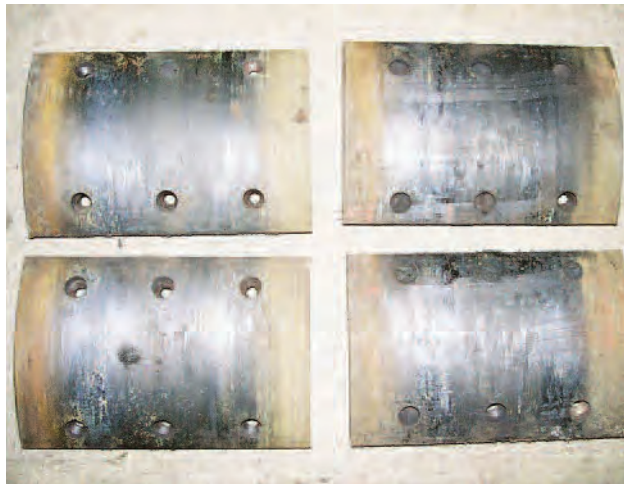
Photo 21: Drum brake; brake blocks overheated.

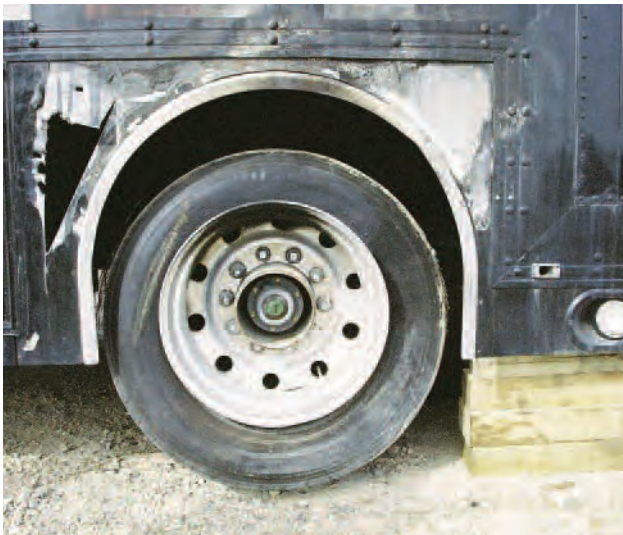
Drum brakes can create a fire hazard similar to disc brakes by supporting the hub load during a bearing failure or by a partial application (stuck) brake. Specifically, if the brakes are applied during vehicle motion, through either the service or parking system, they can create enough friction, leading to extreme heat, that they can cause a tire fire or ignite some other combustible material (Photo 18). Over the last 20 years, engine manufacturers have continually produced engines with high horsepower and torque ratings. These high-output engines are capable of driving through a partially applied service brake or fully applied parking brake. If this were to occur at highway speeds, enough frictional heat can be developed to start a fire (Photo 19).

Photo 19: Tire fire started by dragging parking brake.

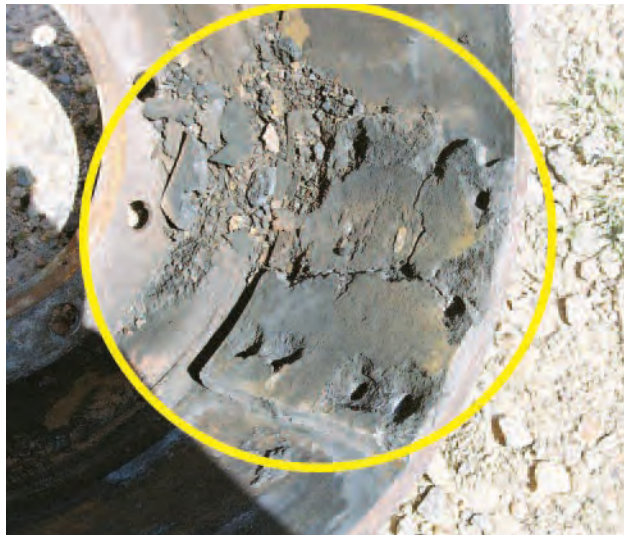
Photo 22: Fused brake block

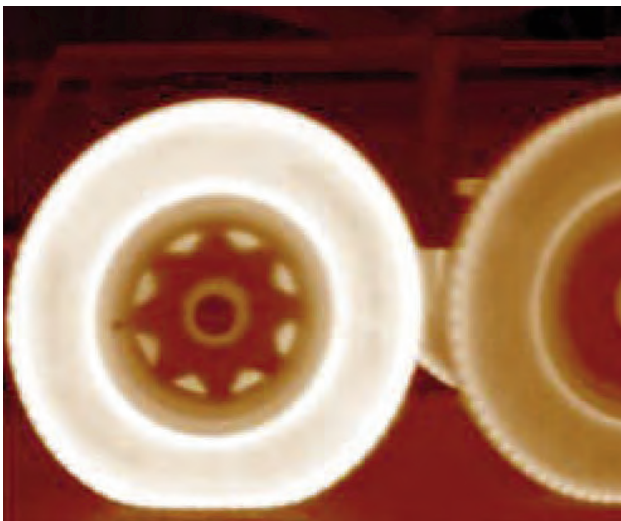
*Photo 23: Thermal scan of overheated tire due to low inflation pressure.*

surface temperature of an object.) (Photo 23). Tires generally revert (melt) at approximately 250 °F and catch fire over the 600 °F mark. It is common, although not mandatory, for the tire fire to occur when the vehicle comes to a stop. This is the condition with the least amount of air flow circulating around the brake rotors, brake drums and tires. Without air flow around these items, their temperature rises rapidly and is transmitted to the tire—subsequently igniting it.

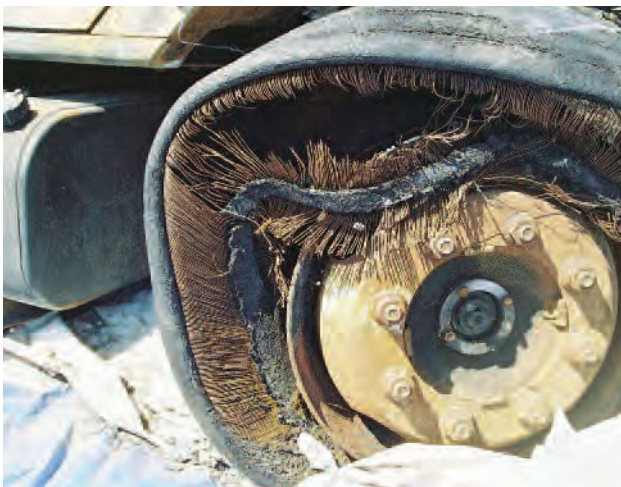
*Photo 24: Straight tire cords indicating no rotation at time of fire.*

Tires, which have ignited during (rotation) travel, can be indicated by the disturbance or twisting of the tire reinforcing cords. Tires that have ignited while stationary (no rotation), have tire cords, which remain largely undisturbed (Photo 24). In general, tires do not become a fire hazard on their own. In most cases, it takes a localized failure of an adjacent component to ignite the tire(s).

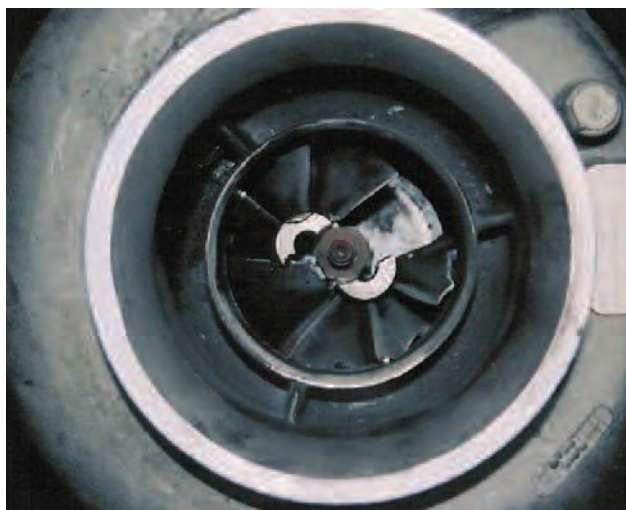
Upon a failure of this bearing system or an imbalance of either the turbine or compressor wheels, contact is made within the turbocharger housing, causing a rapid deterioration of the compressor and turbine (Photo 25). Once the shaft has been reoriented, as a result of any one of the aforementioned failure modes, the shaft seal(s), which controls the lubrication oil within the bearing cavity, subsequently fails allowing oil to enter directly into the hot side (turbine) of the housing and then directly into the exhaust system (Figure 8). This can create an auto-ignition fire within the turbocharger itself or exhaust system.

Photo 25: Failed turbocharger compressor.

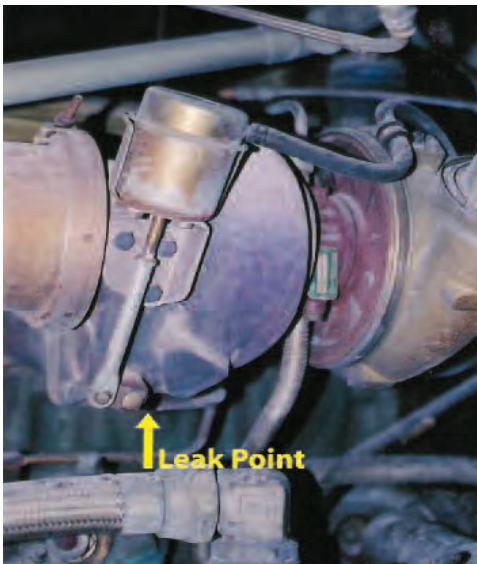
from the waste gate pivot point can be observed (Photo 26). Once oil has begun to leak from this point on the turbocharger, it should be removed from service and the exhaust system should be thoroughly cleaned. To assist in preventing this failure mode, the turbocharger waste gate or variable geometry function (VGT) must be confirmed.

Photo 26: Turbocharger/waste gate.

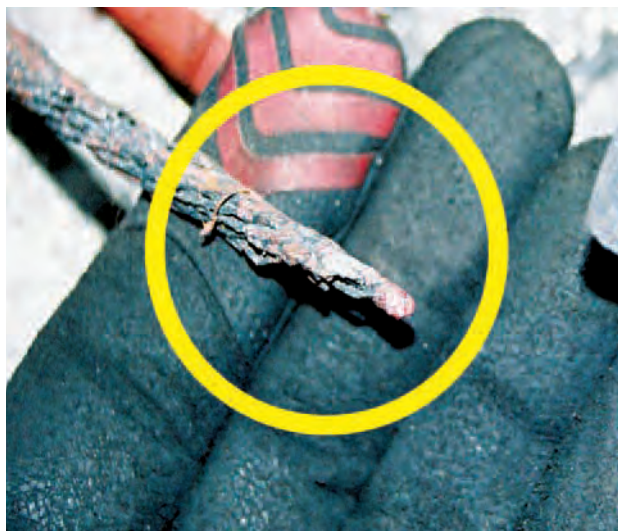
Cable routing and securement is usually a "packaging and housekeeping" item with respect to vehicle design. Cable routing and securement goes hand-in-hand. Loose, pinched, excessive length or breached B+ cables(s) can lead to a high-energy sustained duration spark, which can become an ignition source. For example, "balling," a term used to describe the physical appearance of a cable which has experienced a separation under power, is shown in Photo 29.

*Photo 29: Example of "balling" phenomenon.*

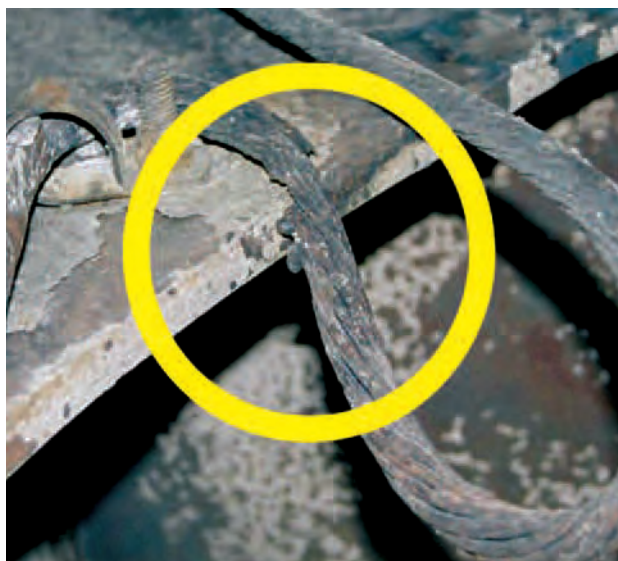
*Photo 30: B+ cable contacting structural gusset, creating B+ to ground.*

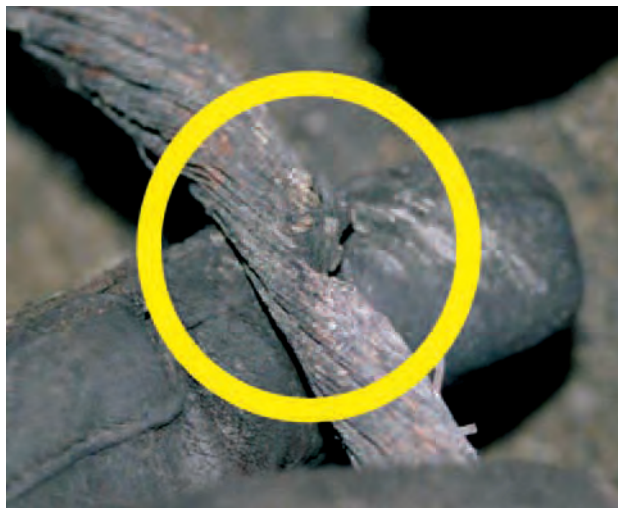
The securement of the cable(s), once routing is established, is vital to prevent the breaching of the insulation or the mechanical failure of a cable connector. In some cases, over time, a B+ cable can move cyclically enough that it will eventually make contact with chassis ground creating a sustained duration high-energy spark (Photo 30). In this case, a clamp (p-clamp) was omitted during assembly, which allowed the B+ cable to dangle enough so it contacted a structural gusset creating arcing (Photo 31).

*Photo 31: B+ cable with "vee" cut from arcing (same cable as in Photo 30).*

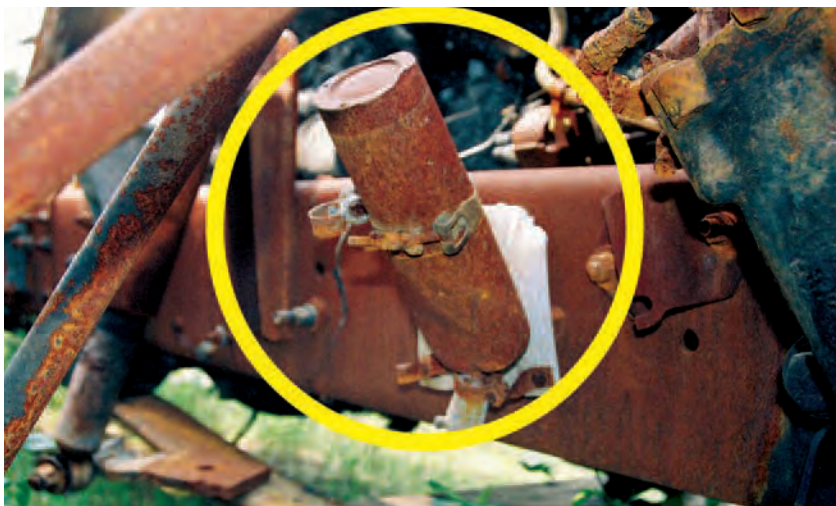
Photo 33: Starting fluid canister shows impact damage.

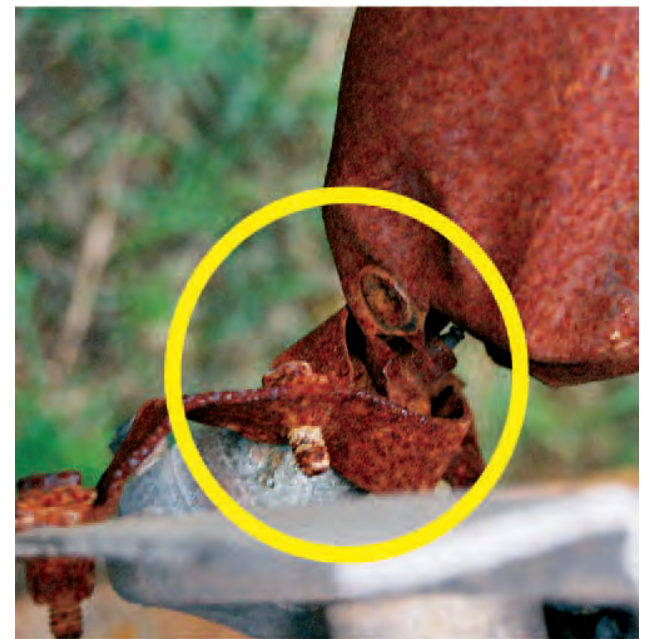
Photo 34: Starting fluid canister (breached).
