**IMECE2006-13305**

**“FIRE AND EXPLOSION INVESTIGATIONS; WHY HEAVY TRUCKS MAY BURN”**

**Christopher W. Ferrone**  
ARCCA, Inc.  
550 W. Van Buren, #1220  
Chicago, IL 60607  
312.386.2300  
cferrone@arcca.com

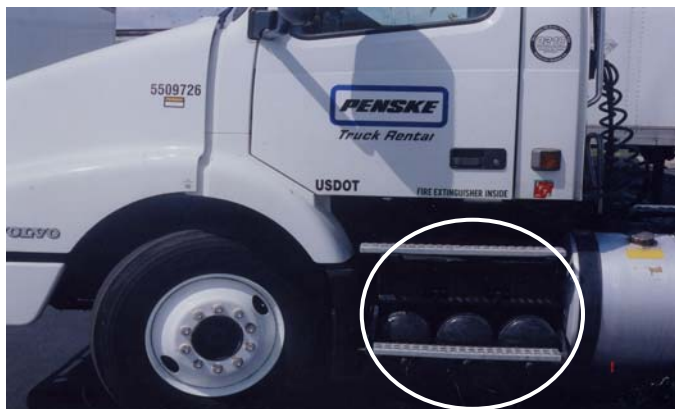
**Photo 1**

On January 9, 2001 on U.S. 49 in the State of Louisiana, a tractor trailer was maneuvering into a driveway to make a delivery. During the process, the tractor was struck by another truck which was attempting to pass. (Fig. 1) The impact was to the driver's side area of the first tractor, specifically, to the

location where the fuel tank and battery box reside (Photo 1).

A witness reported that the first tractor burst into flames upon impact. The driver was trapped and perished as a result of the fire.

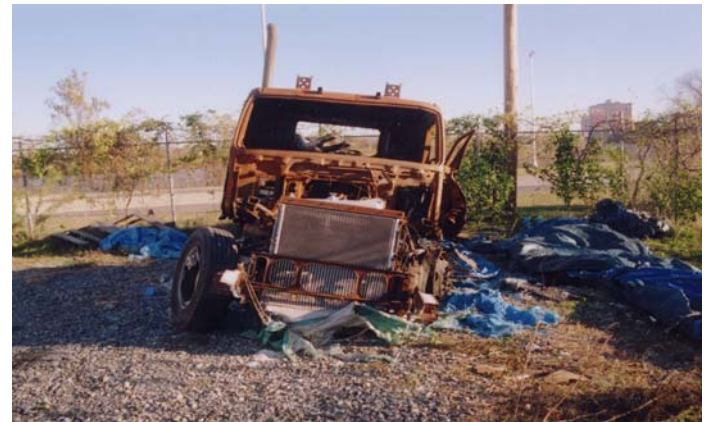
**Photo 2**

Over the past two years we have investigated four similar accidents. In each case a truck tractor was involved in a collision which resulted in an explosion and/or fire. In each of these incidents, the fact pattern was similar, the battery box and fuel tank area were impacted simultaneously or in close sequence. A full scale fire arose destroying the equipment (Photo 2) (Appendix A).

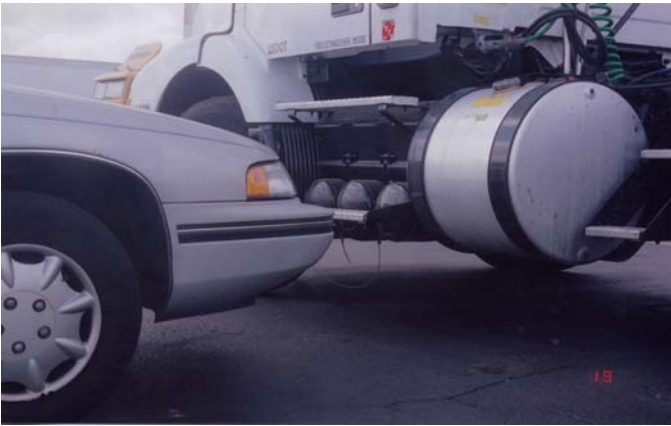
**Photo 3**

In the event of this type of collision, most cars' front bumper will contact the fuel tank of a truck tractor on or about the tank's longitudinal center line (Photo 3). The same goes for pickup trucks, S.U.V.'s and other trucks/tractors front bumpers. This event may then lead to a fuel spill. Additionally, the placement of the battery box in such close proximity to the fuel tank can become an ignition source for the potentially spilled and/or atomized (spray) diesel fuel.

Automotive bumpers range in height from approximately 13" – 23" from the ground.

- Tractor fuel tank centerline approximately 24" from ground
- Tractor battery tray/bracket distance to fuel tank approximately 2"
- Tractor battery tray approximately 25" from ground

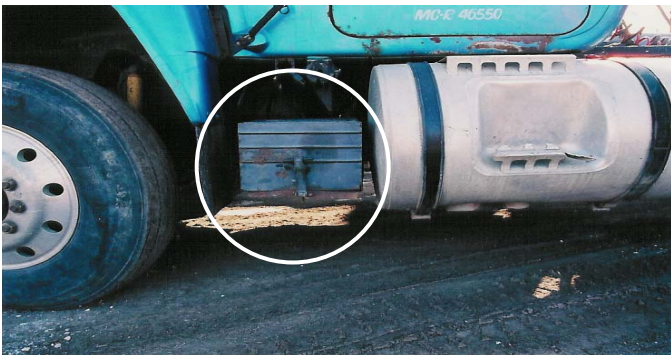
**Photo 4 – Mack R-Model**

A study of various truck tractor battery box and fuel tank locations was conducted. As stated earlier, the contention is that in most cases the battery box resides within inches from the fuel tank. This package of components is not unique to any one

manufacturer (Photo 4).

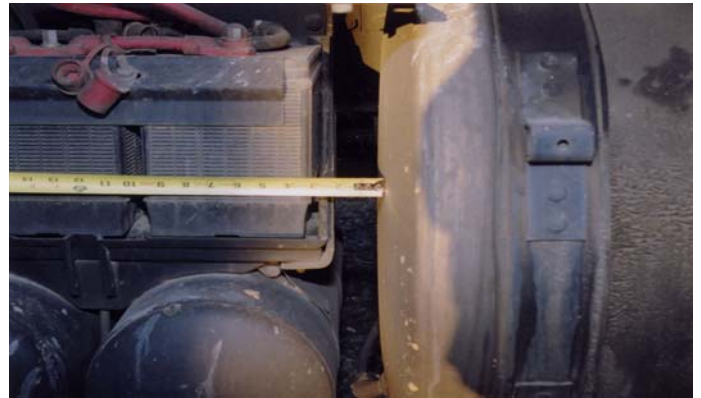
**Photo 5**

In some cases the battery box can be as close as 2 ½ inches from the fuel tank (Photo 5).

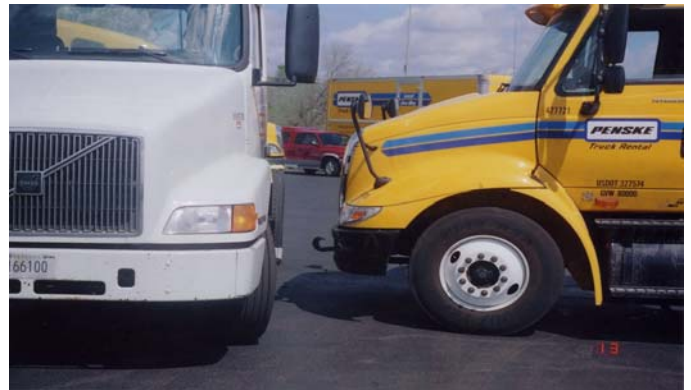
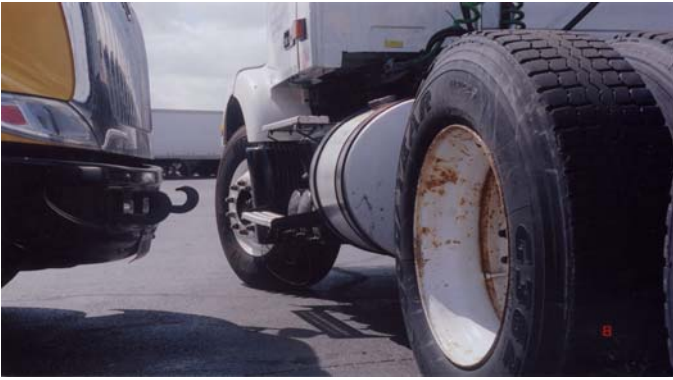
Various measurements and photographs were taken of automobiles and truck tractors interacting along side another truck tractor (Photo 6 & 7). These measurements and photographs clearly show that there is a high likelihood that if a collision was to occur with a truck tractor on the left-hand side near the batteries and fuel tank area that a fuel spill and ignition source (battery) would be present.

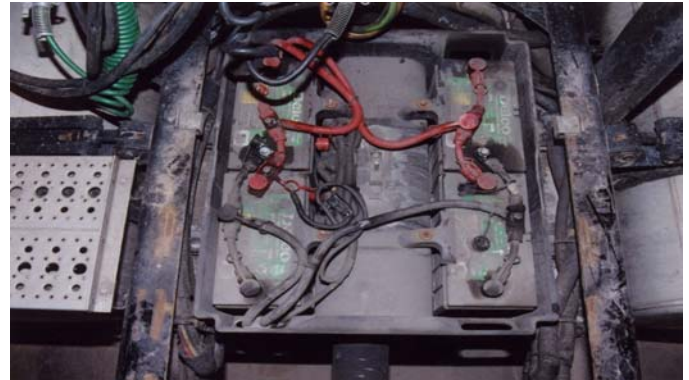
Photo 8 – Batteries Inside Frame Rails, Freightliner Century Class

The reader must realize that relocating the battery box to within the frame rails, as suggested, is not novel to the author. Freightliner Corporation currently employs this design scheme on their Century, Coronado and Columbia tractors. Photograph 8 and dimensional drawings (Fig. 3) of a typical Century Class tractor are included showing the design scheme today. This design dates back to 1996 when it was introduced on the Century Class tractor.

The most practical and beneficial approach to this is to relocate the battery box to inside the frame rails in the already clear/free space just behind the cab.

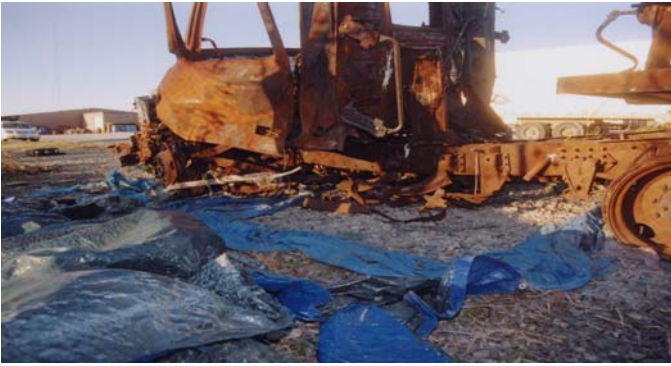
**Photo 9**

- Impact to the battery box and fuel tank area (Photo 9).

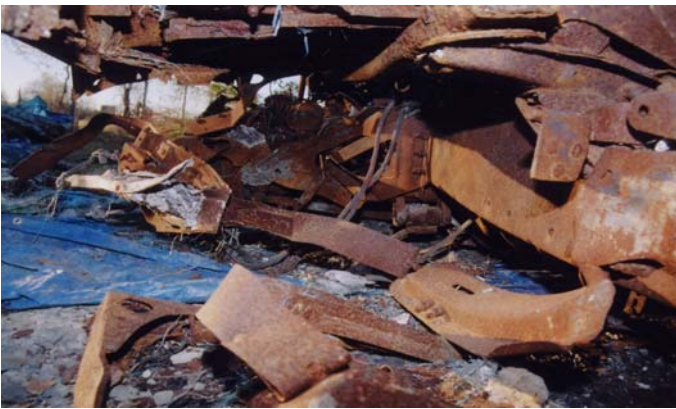
**Photo 10**

- Battery tray and support structures are damaged (Photo 10).

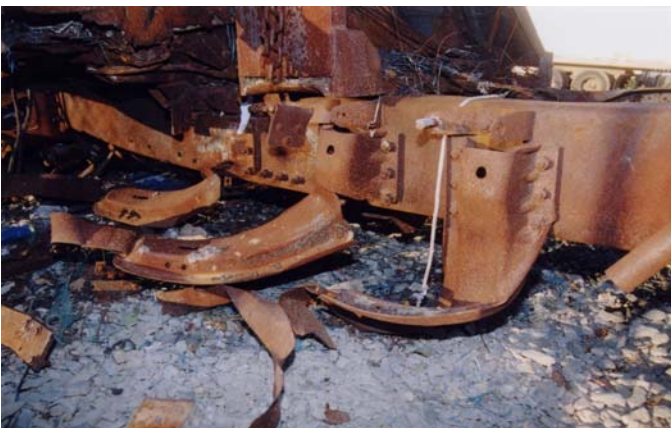
**Photo 11**

- Fuel tank supports are damaged or reoriented (Photo 11).

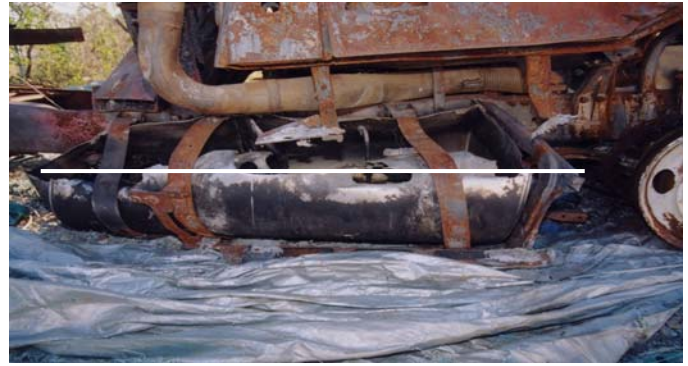
**Photo 12**

- The companion fuel tank (passenger side) of the truck tractor is usually uninvolved from an explosion/fire point of view.

- An uninvolved fuel tank usually shows a volumetric “fuel level line” indicating how much fuel was in the tank at the time of the fire (Photo 12).
- In some cases there was evidence of the battery box being pushed into the fuel tank towards the rear of the tractor (Photo 13).

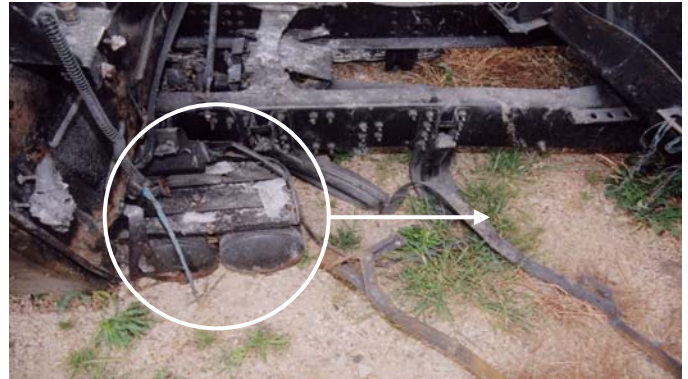
**Photo 13 – Battery Box Moved Rearward**

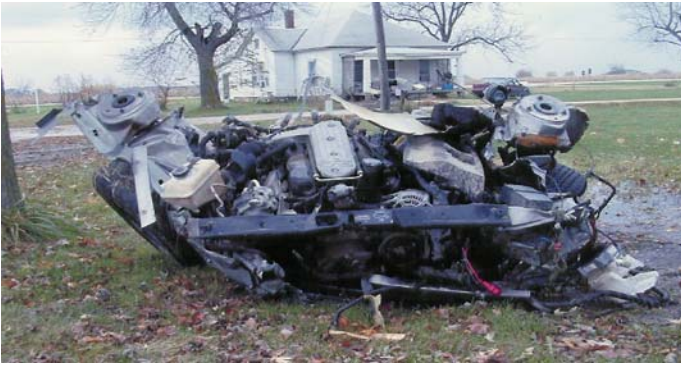
In all of these investigations alternate sources of ignition were evaluated. In each one, the bullet vehicle was inspected and concluded not to be an independent ignition source of these fires. Specifically, the striking vehicle was inspected to see if any signatures were present that would determine that it was the ignition source. In each of the four investigations, the striking vehicle was ruled out as the ignition source (Photos 14 & 15).

**Photo 14 – Striking Vehicle (no fire signatures)**

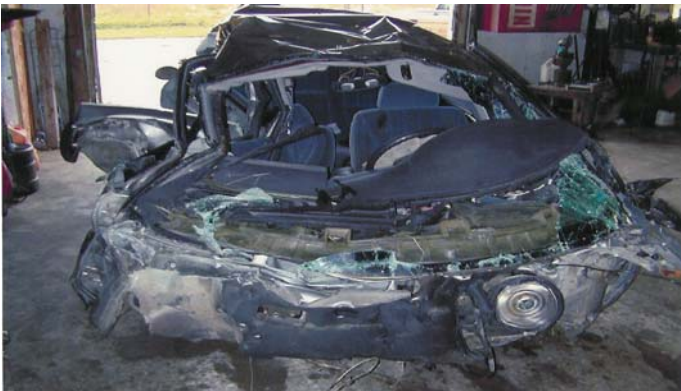
**Photo 15 – Striking Vehicle (no fire signatures)**
