IMECE 2009-10522

**FIRE, CAUSE AND ORIGIN OF HEAVY VEHICLES
(MECHANICAL AND FORENSIC METHODS)**

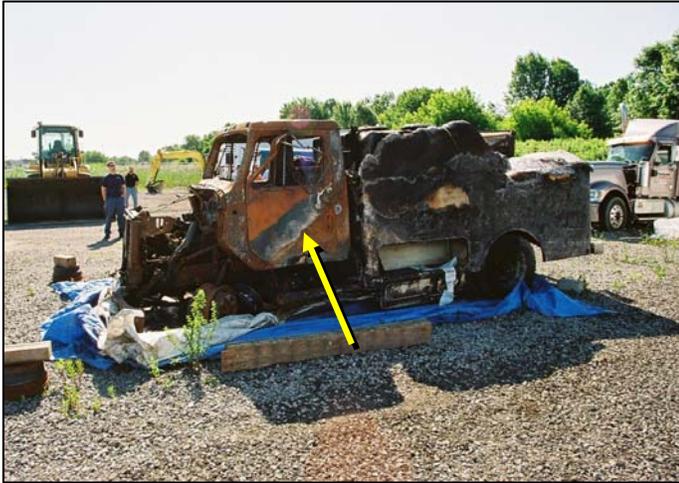
Photo 2A: Burn Pattern

This analysis involves the observation of flame/heat damage patterns leading to the origin of the fire (Photo 2A). The technique is generally comprised of the elements shown in the flow chart (Appendix A) and come from N.F.P.A. 921. This method is further facilitated by reassembling the truck (as much as possible) to show configuration and component placement (Photo 2B).

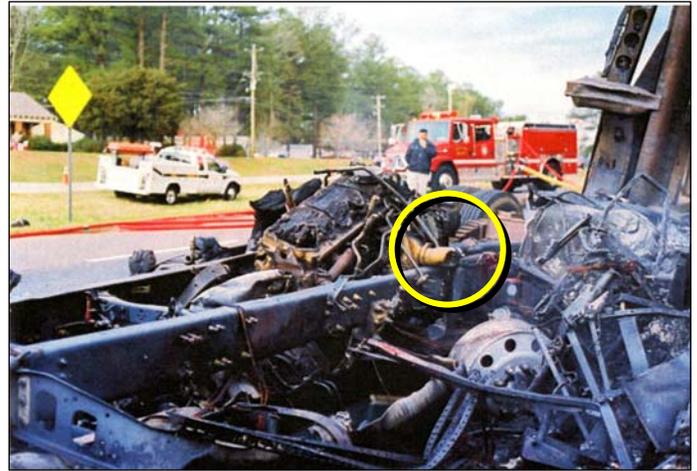
Photo 3A: Turbocharger, Impact Damage

In many fires, the origin evidence is burned. This leaves the investigator with a difficult task. A competent method of analysis, if left with this situation, is to systematically eliminate ignition and combustible sources one by one using observations, mechanical function, system logic and reconstruction. Each of the components listed in the common causes section should be evaluated. For example, Photograph 3A shows the truck engine, at the accident scene, with the dual turbochargers off the engine. Photograph 3B shows rough edges on the turbocharger connection indicating a traumatic impact failure. Therefore, since these turbochargers were knocked off the engine in the accident phase and reside on the

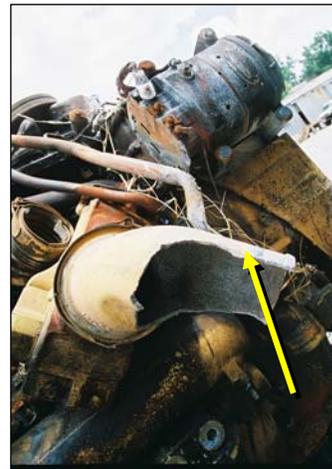
Photo 3B: Turbocharger,
Impact Damage,
Rough Edges

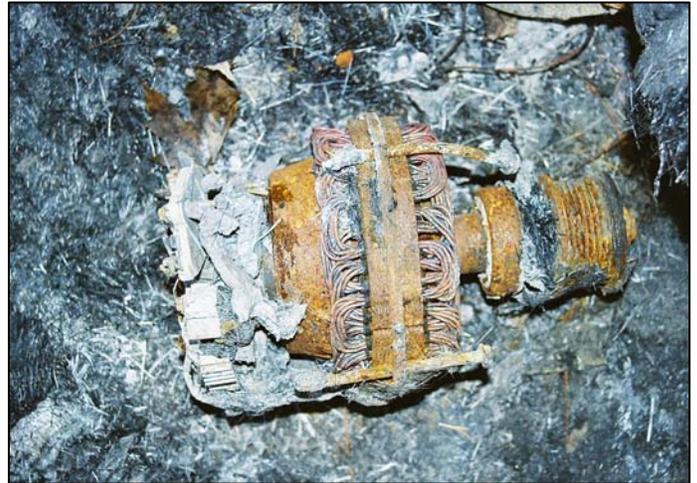
In some instances a fire has begun with the vehicles' engine off and after some period of time since the most recent engine shut-down. This can be attributed to an internal alternator failure; in some instances a diode failure. Diodes act as a one-way check valve for current. Typically, if a diode fails in this scenario, positive (B+) battery voltage/current goes to ground and has been known to start a fire (Photos 4A and Appendix B).

Photograph 4A shows an alternator that was determined to be the cause of this fire. Photograph 4B shows the alternator of a truck, parked next to the truck in Photograph 4A, however, completely different appearances, despite being involved in the same fire only a few feet apart.

The alternator in Photograph 4A was found on the ground next to the truck, when it was picked up, it had created an unburned area on the floor. This indicates that it fell to the ground prior to anything else falling on that spot and covering the floor in that area. The solution to this potential fire scenario is to park the truck with the main battery switch off. This will disconnect the batteries from the alternator eliminating this potential.

Photo 4A: Causal Alternator

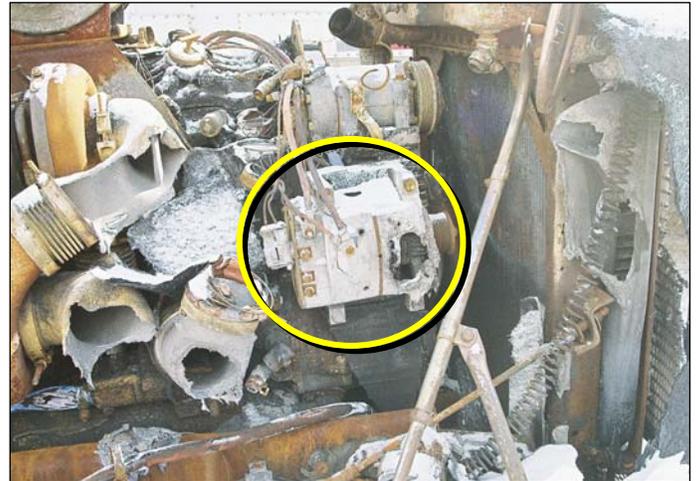
Photo 4B: Non-Causal Alternator

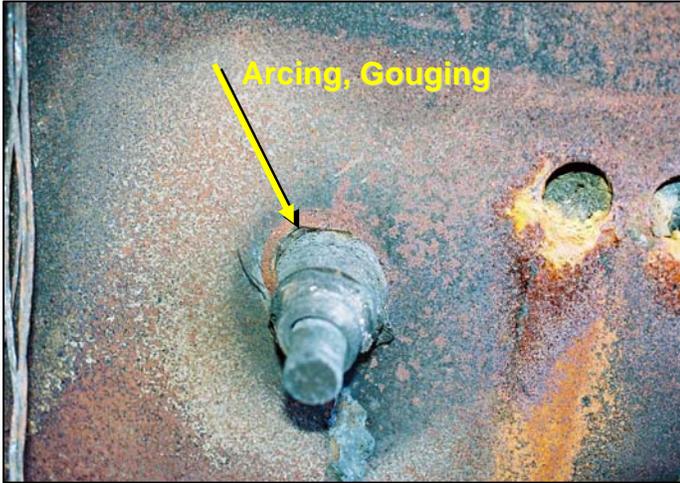
Photo 5B: B+ Jump Post, Battery Box

This boot must be in good condition and over the positive (+) stud at all times. A loose jumping stud/cable, or if it is contacted during a collision, can create a sustained duration high energy spark (Photo 5B).

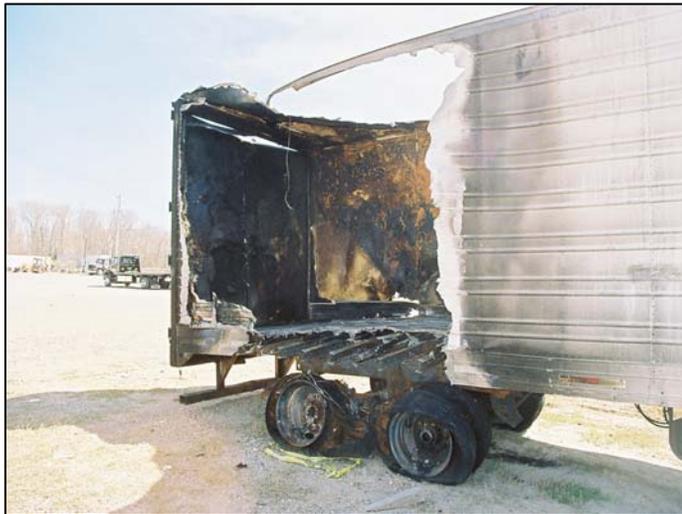
Photo 6: Hub Failure/Tire Fire

Photograph 6 shows a burned trailer which experienced a hub failure. This failure was caused by low hub oil level. This condition ultimately led to the fire which started at the tire. This is indicated by the deformed (melted) bearing rollers (Photo 7A). Bearing rollers, with this appearance, can only occur when

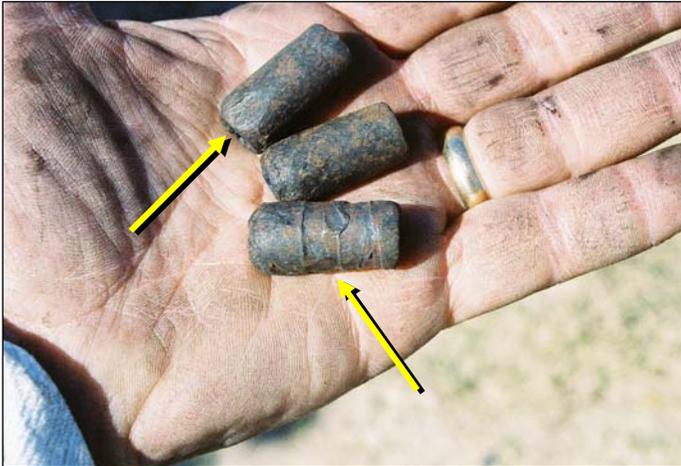
Photo 7A: Deformed Bearing Rollers

the hub oil level is low. This deformation can not occur due to the fire. Low hub oil levels create extremely high heat (Photo 7B). The weight of the load, that the bearing supports, creates pressure on each bearing roller. This pressure coupled with the extreme heat creates the rollers deformation. Once this occurs, the tire(s) near this area can ignite.

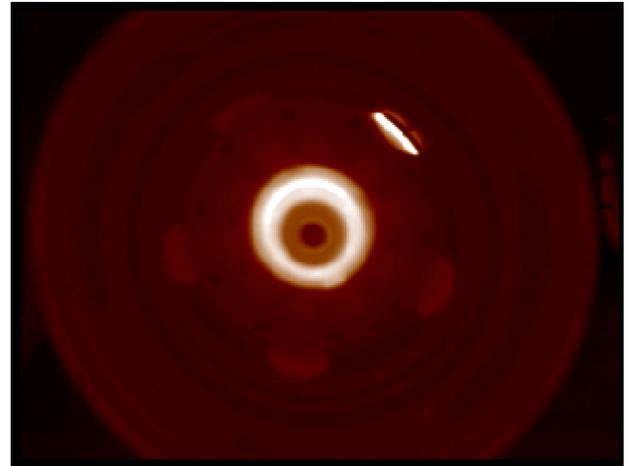
Photo 7B: Thermal Scan; Overheated Wheel Bearing

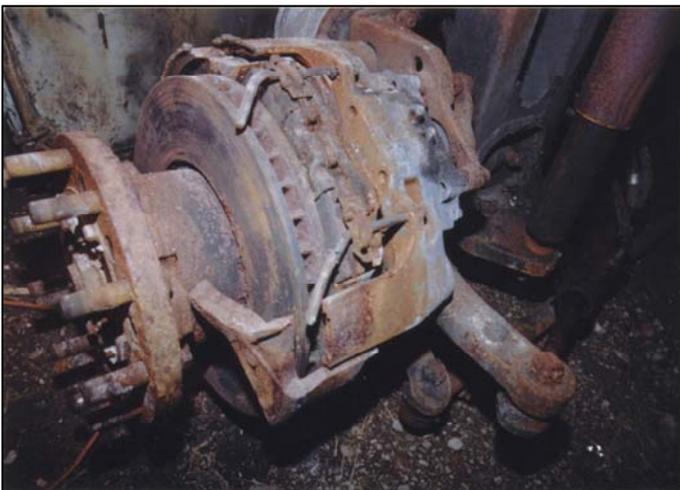
Photo 8: Causal Disc Brake/Wheel End Failure

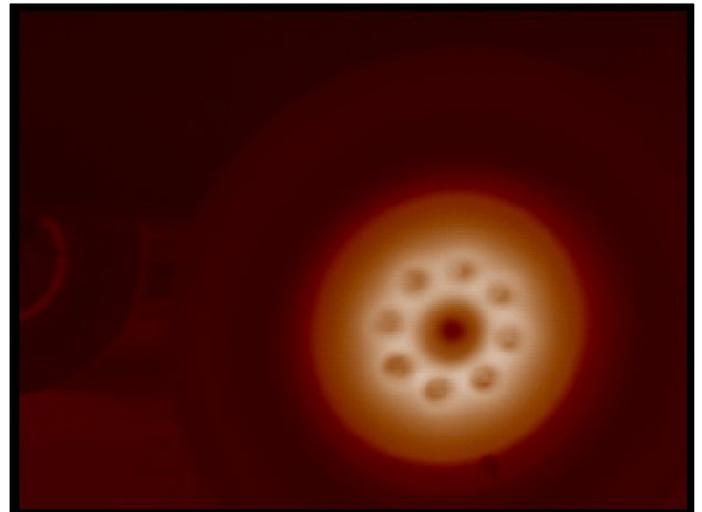
Photo 10: Thermal Scan: Over-Heated Brake Drum

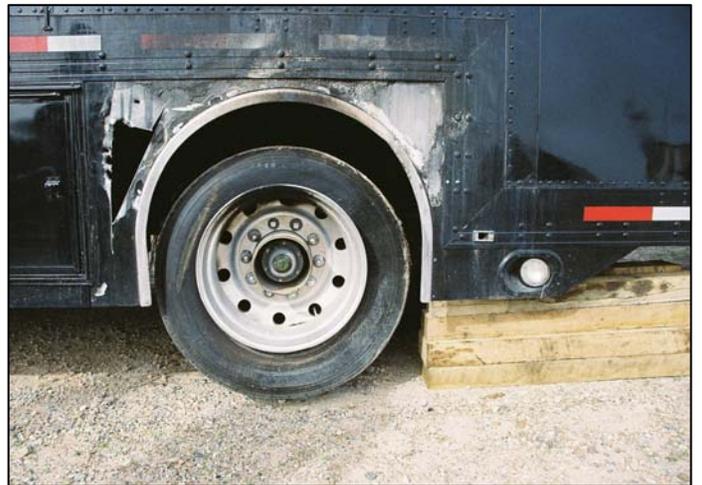
Photo 11: Tire Fire Started by Dragging Parking Brake

horsepower and torque ratings. These high output engines are capable of driving through a partially applied service brake or fully applied parking brake. If this was to occur at highway speeds, enough frictional heat can be developed to start a fire (Photo 11).

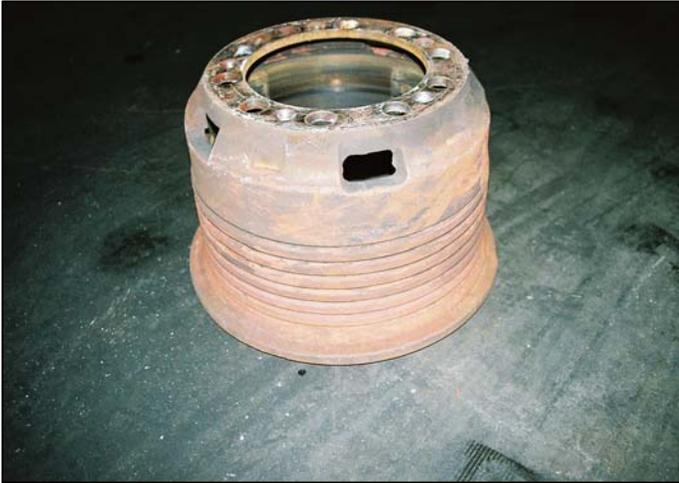
Photo 12A: Brake Drum Rouging Caused by Overheating

Various pneumatic and mechanical issues can prompt a brake failure which can lead to a fire. Generally speaking, when drum brakes approach this scenario, they leave signatures. Brake drums may show signs of rouging (Photo 12A) and the matching brake blocks may show a burn pattern if not damaged by the fire (Photo 12B). In the extreme case the brake blocks can become fused to the drum as a result of the bonding agent (resin) of the brake blocks actually beginning to melt and burn (Photo 13).

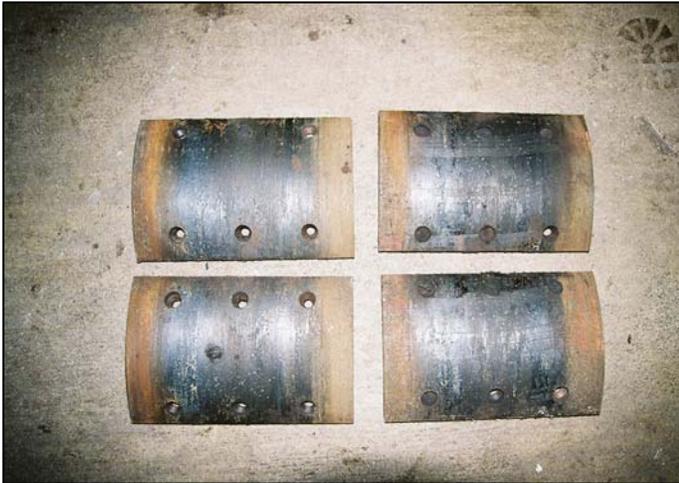
Photo 12B: Drum Brake; Brake Blocks Overheated

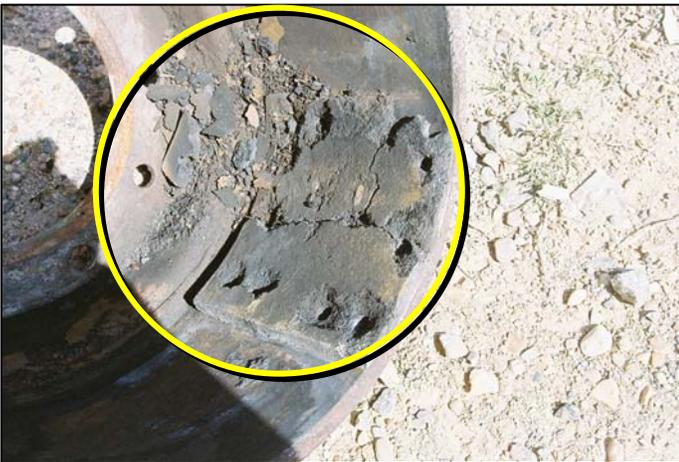
Photo 13: Fused Brake Block

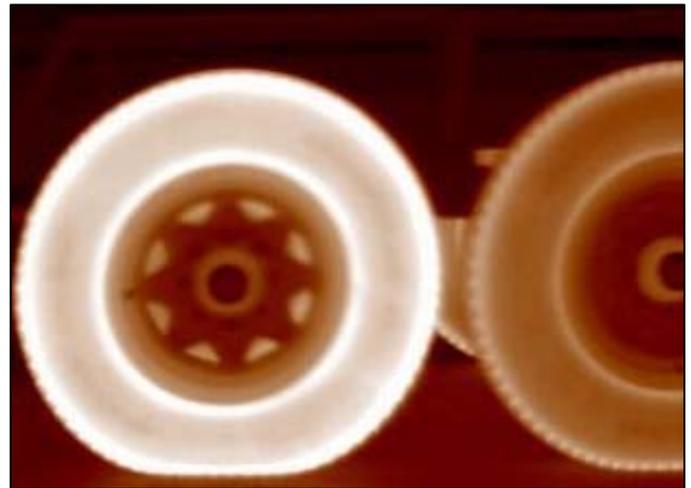
Photo 14: Thermal Scan: Overheated Tire, Due to Low Inflation Pressure

Therefore, operators should always ensure that all tires, especially dual tires, are inflated and not in contact with one another. In general, operating temperatures for radial tires can be anywhere between ambient plus 60°F (150°F-180°F). Under severe conditions the operating temperatures will range in the 200°F area¹ (Photo 14). Tires generally revert (melt) at approximately 250°F and catch fire over the 600°F mark. It is common, although not mandatory, for the tire fire to occur when the vehicle comes to a stop. This is the condition with the least amount of air flow circulating around the brake rotors,

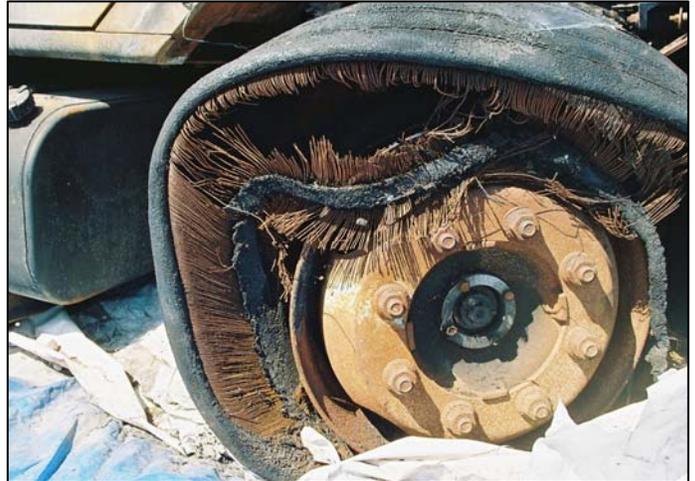
Photo 15: Straight Tire Cords Indicating No Rotation at Time of Fire

Tires which have ignited during (rotation) travel can be indicated by the disturbance or twisting of the tire reinforcing cords. Tires that have ignited while stationary (no rotation), have tire cords which remain largely undisturbed (Photo 15). In general, tires do not become a fire hazard on their own. In most cases it takes a localized failure of an adjacent component to ignite the tire(s).

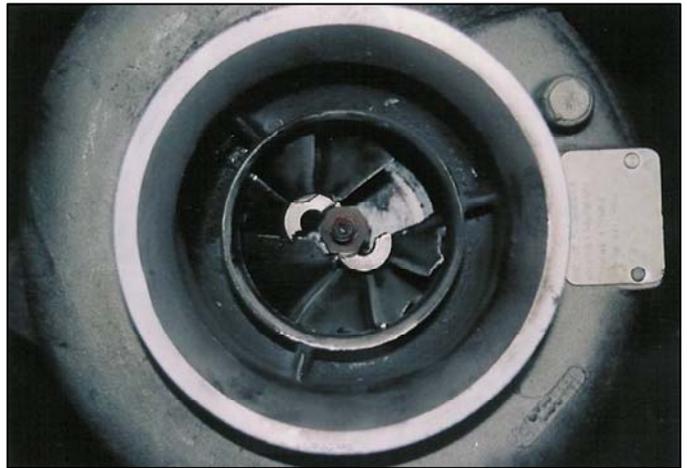
Photo 16: Failed Turbocharger

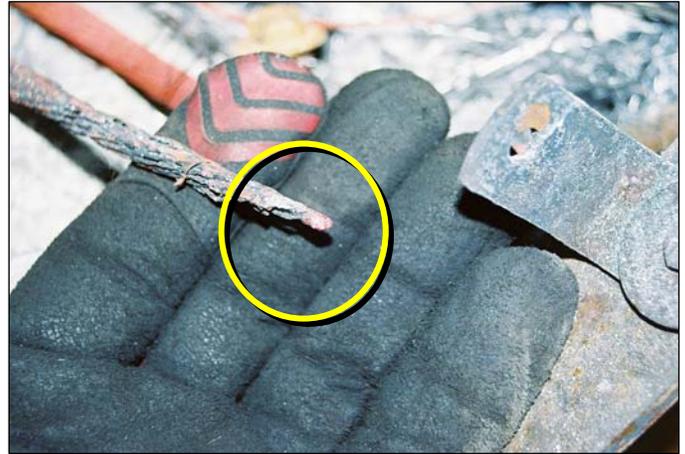
Photo 20: Example of "Balling" Phenomenon

excessive length or breached B+ cables(s) can lead to a high energy sustained duration spark which can become an ignition source. For example, “balling”, a term used to describe the physical appearance of a cable which has experienced a separation under power is shown in Photograph 20.

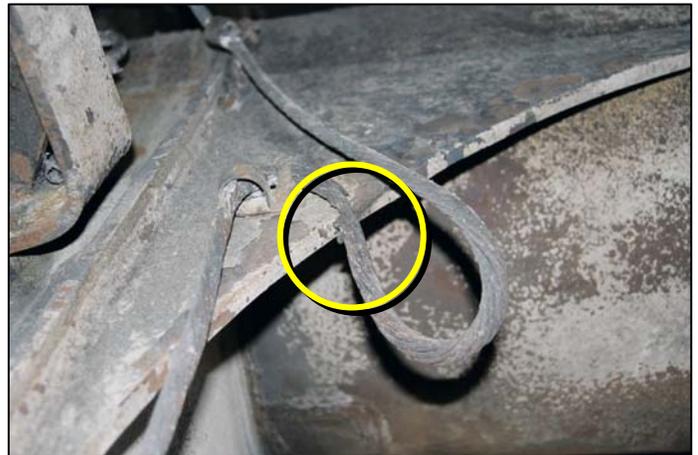
Photo 21: B+ Cable Contacting Structural Gusset Creating B+ to Ground

Cables which can be contacted during the collision phase of an accident can become an ignition source. The securement of the cable(s), once routing is established, is vital to prevent the breaching of the insulation or the mechanical failure of a cable connector. In some cases, over time, a B+ cable can move cyclically enough that it will eventually make contact with chassis ground creating a sustained duration, high energy spark (Photo 21). In this case a simple clamp (p-clamp) was omitted during assembly which allowed the B+ cable to dangle enough so it contacted a structural gusset creating arcing (Photo 22).

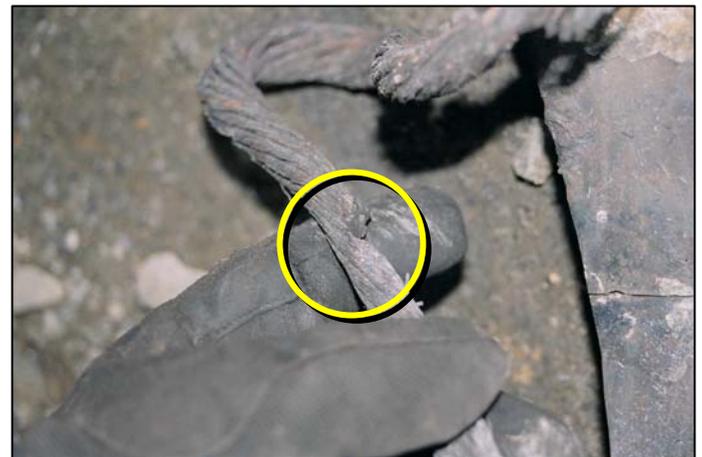
Photo 22: B+ Cable with "Vee" Cut from Arcing (same cable as in Photo 21)

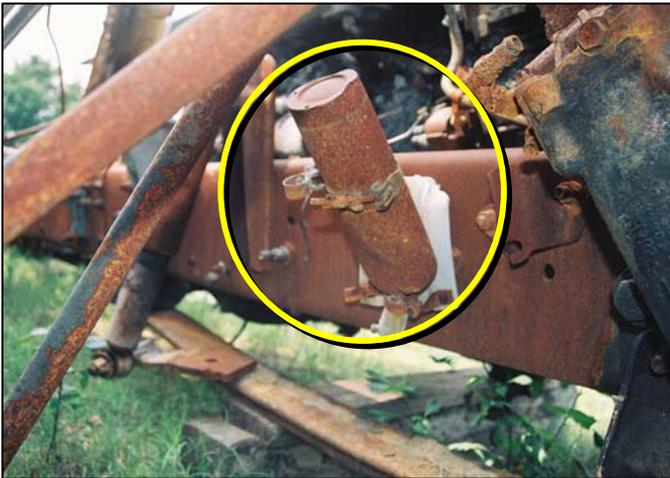
Photo 24A: Starting Fluid Canister-Impact Damage

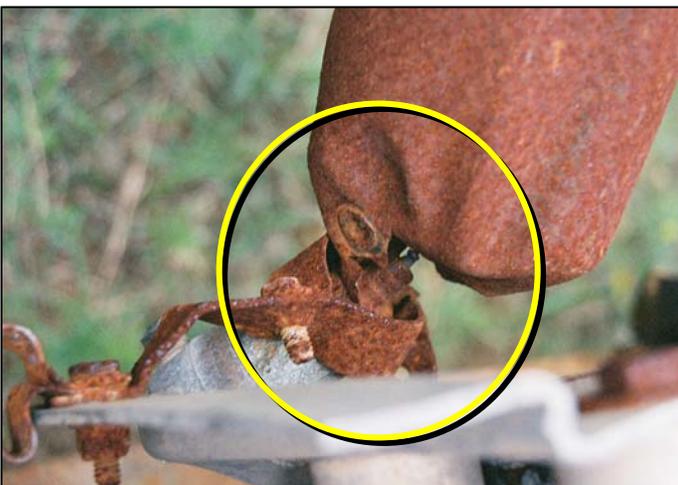
Photo 24B: Starting Fluid Canister (Breached)
