Reprinted with permission from the  
September 2014 issue of *Claims* magazine

# Lights, Camera, Crash — The Story of a Staged Crash

By Shawn Harrington, Larry Sicher and William Brem

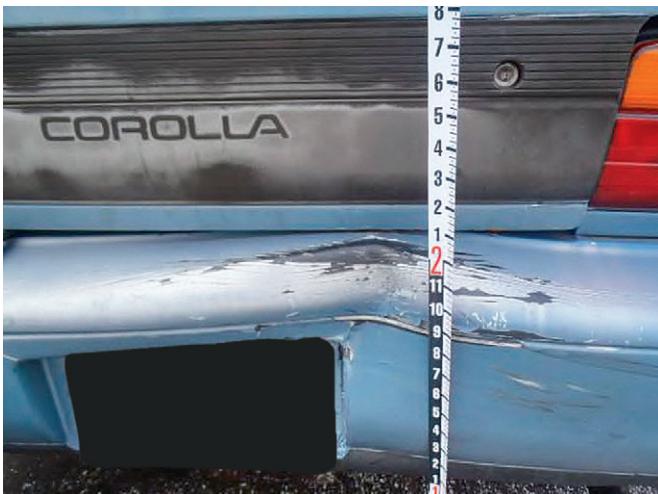
As seen in Figure 1, the top of the Corolla's rear bumper is approximately 23 inches, this is in agreement with other data that was

The damage seen in Figures 1 and 2 also showed no signs of paint transfer and the striking Accord was reported to be blue in color. Clearly the direct contact damage seen in the photographs of the subject Corolla included areas above 22 inches and was not of a shape consistent with the profile of an Accord front bumper that was

directly behind the Corolla. Using this information, the accident reconstructionist was able to definitively conclude that the damage as seen on the Corolla was not consistent with the driver's testimony and the claim was denied.

Figure 1 – Case Study 1, Rear of Toyota Corolla

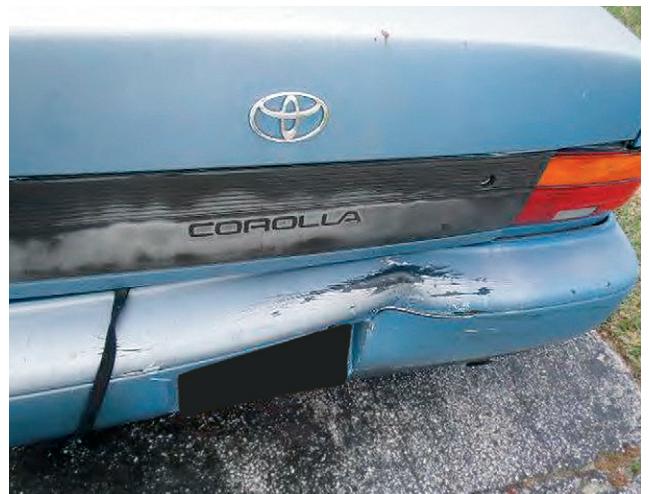
Figure 2 – Case Study 1, Rear of Toyota Corolla, top down view

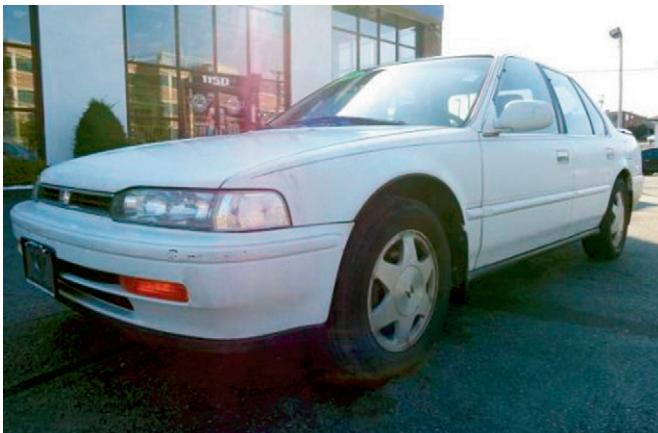
The exact year of the phantom vehicle was unknown but research included a range of Honda Accords from the model years of 1990 through 2006. As seen in Figures 3 and 4, these vehicles had a front bumper that was essentially flat in the center area and contoured smoothly towards the outer bumper edge. The Accords during this timeframe were also available in both 2 and 4 door models. Data was researched for the different model years and variants and it was found that the top of the bumper of these vehicles was always at or below 22 inches.

Figure 3 – Case Study 1, Front of an Exemplar 1993 Honda Accord

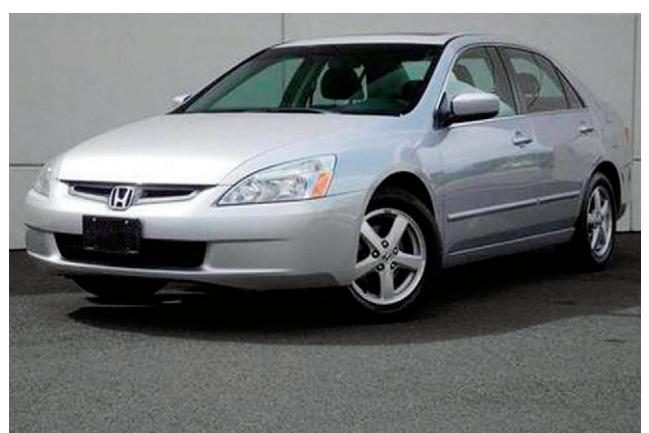
Figure 4 – Case Study 1, Front of an 2003 Exemplar Honda Accord

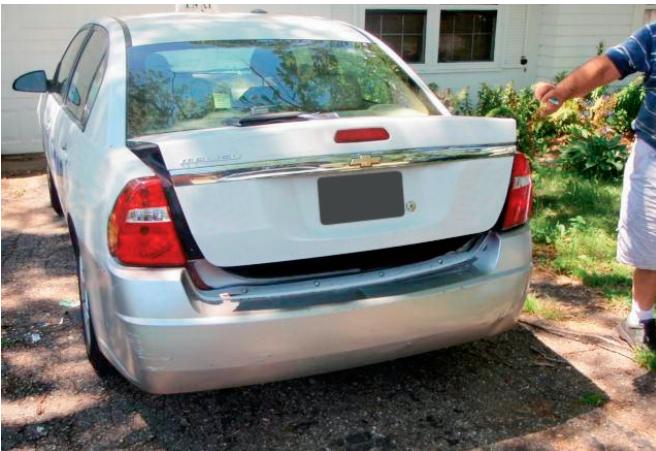
In this case, there was minor contact between the rear of a Chevrolet Malibu (Figures 5 and 6) and the front of a Hyundai Elantra (Figures 7 and 8). In addition, the scuff on the Elantra was noted to be consistent with a sliding motion, consistent with the left front of the Elantra contacting and sliding past the right rear corner of the Malibu.

Figure 5 – Case Study 2, Rear of Chevrolet Malibu

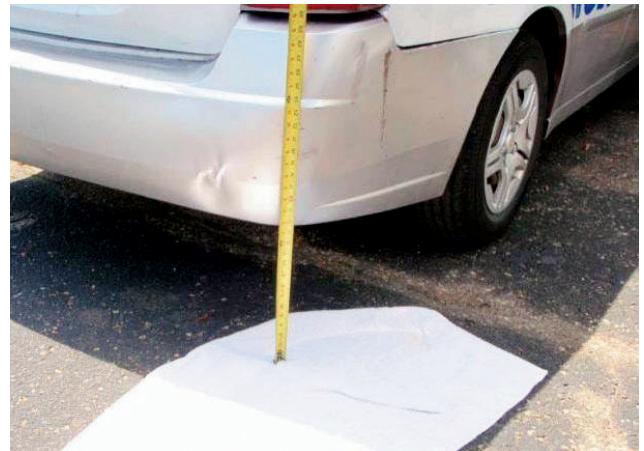
The driver of the Malibu claimed that in addition to the small dented area seen on the right rear corner of the rear bumper cover (Figure 6) that there was damage from this impact to the Malibu's trunk area (Figures 9 and 10). The claimed damage to the trunk area was more prominent on the left side of the vehicle.

Figure 6 – Case Study 2, Rear of Chevrolet Malibu

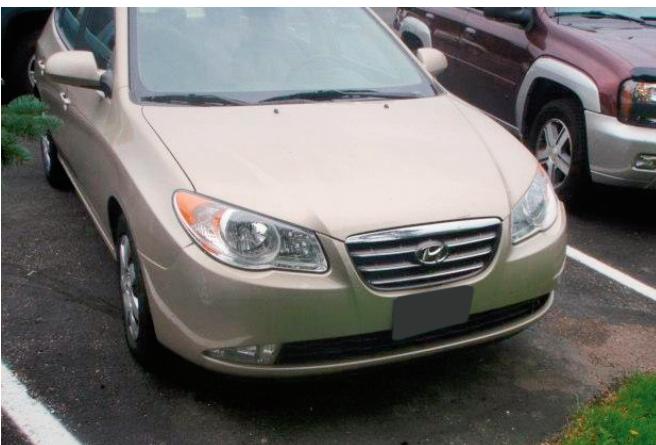
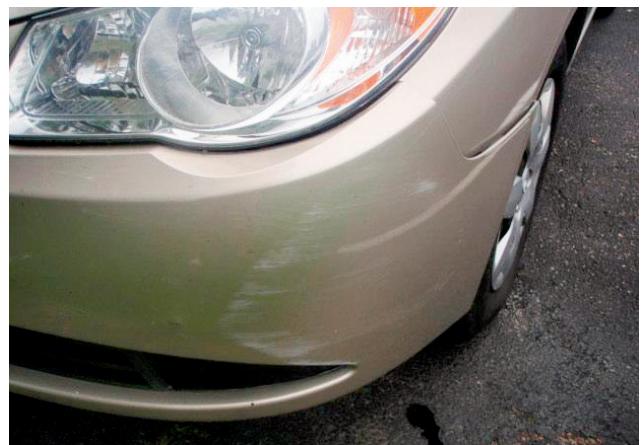
The front bumper of the Elantra comprises a painted plastic cover over a foam absorber and a steel reinforcement bar. The accident reconstructionist engineer had test data on an Elantra from the same model run from a 3-mile-per-hour corner impact test. This data indicated that as a result of a

3-mile-per-hour impact into the front corner of the vehicle, the headlamp was driven into the fender, bending the leading edge of the fender. The lack of additional damage to the incident Hyundai Elantra is indicative of less energy transfer or force applied to the incident Hyundai Elantra compared to the tested vehicle. Therefore, based upon the fundamental laws of physics and coefficients of restitution, the damage for the incident 2007 Hyundai Elantra is consistent with a collision resulting in a Delta-V at less than 4.2-miles-per-hour. (The Delta-V is the change in velocity of the vehicle from its pre-impact, initial velocity, to its post-impact velocity.) A Conservation of Momentum analysis was then performed. Given the mass difference between the incident Hyundai Elantra and the subject Chevrolet Malibu, the fundamental laws of physics and conservation of momentum calculations dictate that an impact resulting in a Delta-V of 4.2 miles per hour for the Hyundai Elantra would result in a Delta-V of 3.5

Figure 7 – Case Study 2, Front of the Hyundai Elantra

Figure 8 – Case Study 2, Front of the Hyundai Elantra

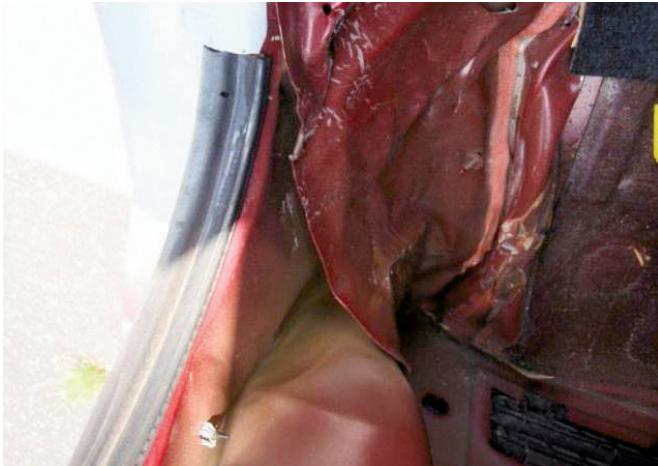
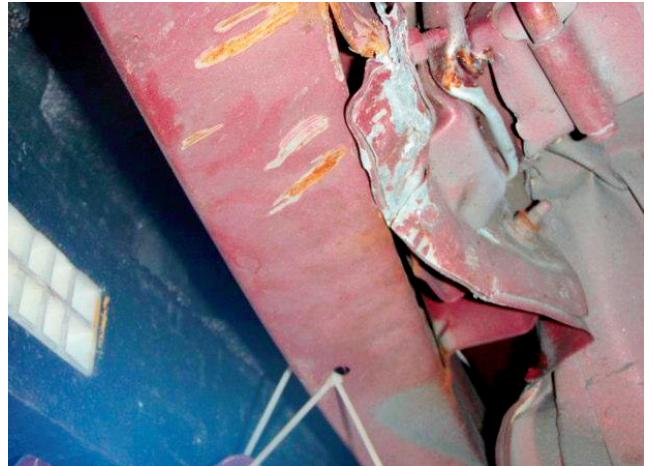
The 5 mph IIHS test represented a condition nearly twice as fast as what was experienced by the subject Malibu in this incident. However, the claimed damage was even more severe and the damage was partially in an area that was remote from the actual contact point.

From this analysis, the accident reconstructionist was able to determine that not all

**Figure 9 – Case Study 2, Trunk area of the Chevrolet Malibu**

**Figure 10 – Case Study 2, Trunk area of the Chevrolet Malibu**

of the claimed damages to the Malibu could be attributed to contact from the Elantra.

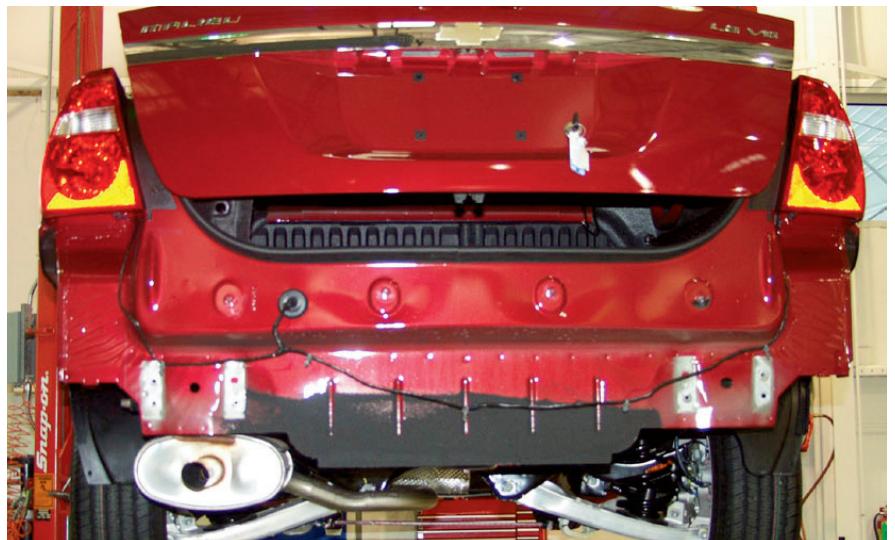
Test data was obtained from the Insurance Institute for Highway Safety (IIHS) for the Chevrolet Malibu. The rear bumper system of a 2007 Chevrolet Malibu uses a foam absorber mounted between a steel bumper reinforcement bar, a flexible plastic bumper cover, and a stiff foam block inserted into its center. The bumper reinforcement has an additional reinforcement welded to its center and is bolted to frame sidemember end flanges at the rear body panel. The damage sustained to the rear of the tested Chevrolet Malibu in the 6.75 mph Delta-V impact into a flat barrier is shown in the Figure 11.

**Figure 11 – Case Study 2, Trunk area of the IIHS tested Chevrolet Malibu at 5 mph, showing no deformations to the trunk area**
