Automobile Injury

Did a Faulty Repair Cause the Accident?

In some cases, an engineering expert can pinpoint a critical mechanical deficiency

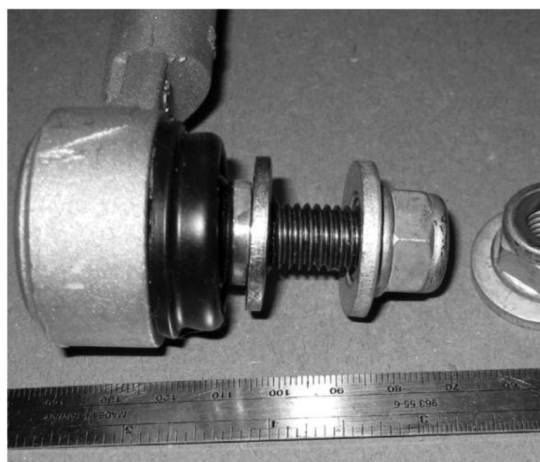
Figure A: Newly purchased replacement end link with included hardware that includes the proper captive nut with insert

that a local repair facility had recently replaced both pairs of front and rear stabilizer bar links. The newly acquired exemplar stabilizer bar end link kit included fasteners (nuts) with captive inserts designed to prevent the attachment nuts from loosening after installation from normal road use and vibration. When compared against the hardware observed on the subject SUV, it became clear that common hex nuts without locking inserts were installed by the repair facility instead of the proper hardware (locking nuts) provided with the replacement end links.

This finding uncovered the stabilizer link's mechanism of fracture failure. The common hex nuts installed had loosened from vibration and cyclic loading of the vehicle suspension over time, until the link completely separated at its bottom attachment. The end link was then free to swing beyond its intended position, thus contacting an adjacent suspension component, causing interference with other suspension components. The link became trapped and loaded in compression by an adjacent suspension arm and then fractured. This mechanism created forensics in the form of scrapes and bending of the suspension arm. (See Figures A and B.)

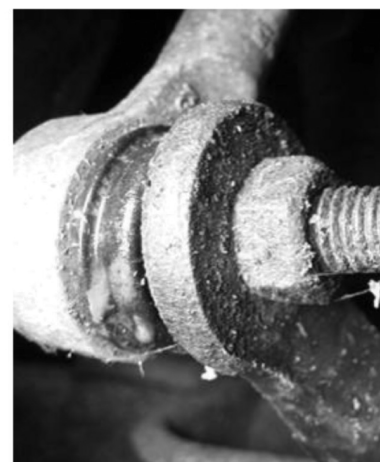
Figure B: Improper hardware used on left rear link

Further examination of the SUV revealed that the upper connections for these stabilizer bar links had been installed with incorrect fasteners. One of these end links had been loose for a period of time prior to the crash.
