STAGED ACCIDENTS

What to Do When Something About That Accident Claim That Just Landed On Your Desk Doesn't Add Up...

By Bill Brem, AS, ACTAR

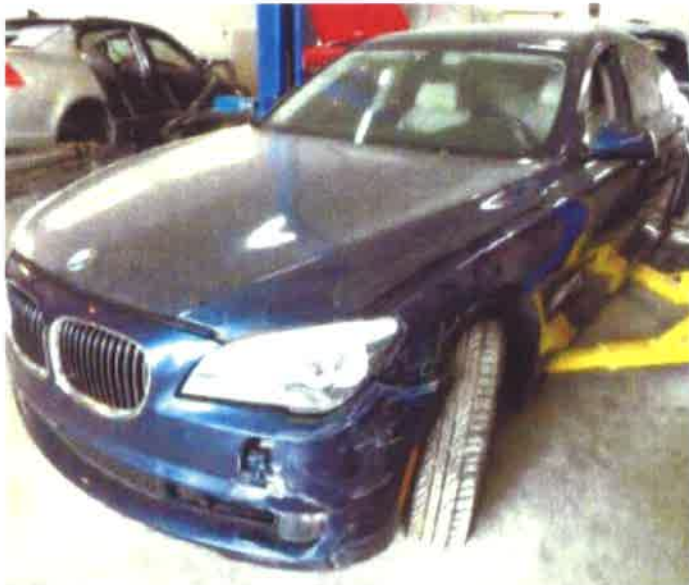
Figure 1: Front and left (driver) side view of the BMW 750i sedan.

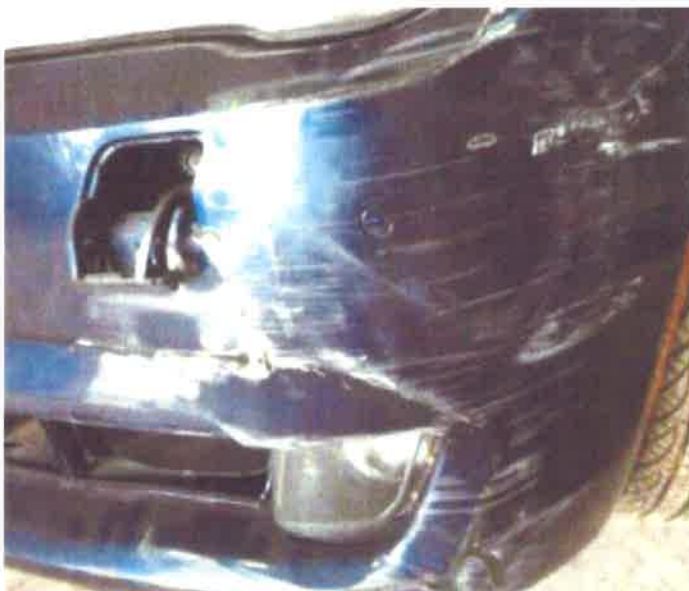
Figure 2: Reported damages to the front left (driver side) bumper cover on the BMW 750i sedan. Note: Scrape markings are all horizontal and straight, running parallel with each other.

An inspection of the vehicle showed there were two separate impact areas - the front left and the rear left - which is inconsistent with the police report diagram, the laws of physics and vehicle dynamics. The damages to the front left bumper cover were all horizontal and straight, running parallel with each other, making them consistent with a sideswipe impact. However, the scratches located on the front left headlamp lens cover were not horizontal - they were straight and running parallel with each other. This would indicate that the damages were not related to each other and more than likely occurred during separate incidents.

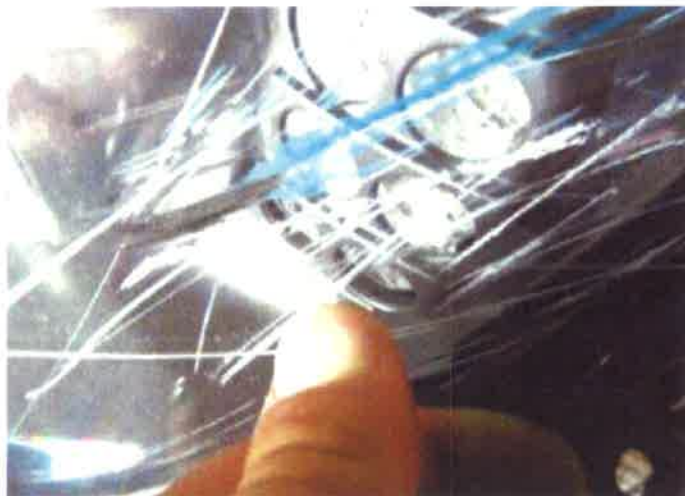
Figure 3: Front left (driver side) headlamp lens cover. Note: Scrape markings are not horizontal and straight, not running parallel with each other like those in Figure 3 above.

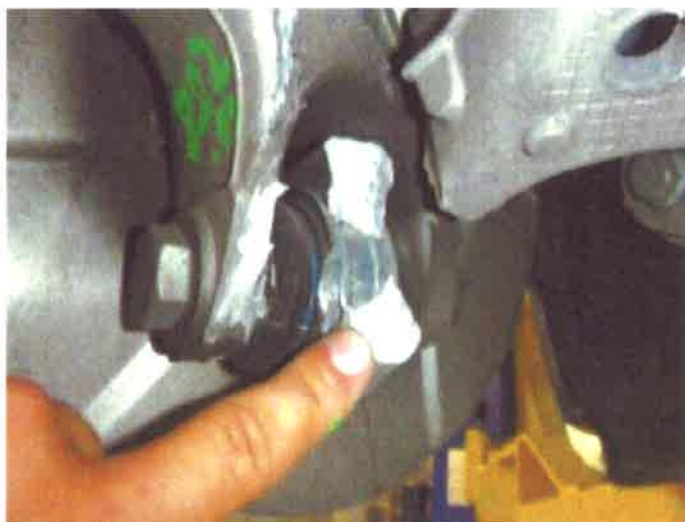
Figure 4: Close-up view of the reported damage to the lower left rear suspension control arm.

Also, a broken lower left rear suspension control arm and/or a broken front steering inner tie rod would render the BMW 750i sedan undrivable. The photographs, which were taken three days after the incident, show oxidation on the broken tie rod end, and the lack of any "circumferential markings", which are the marks left around the spokes of a wheel in a circular pattern when the wheel is rotating upon impact, further confirms that this vehicle was stopped when the damage occurred.

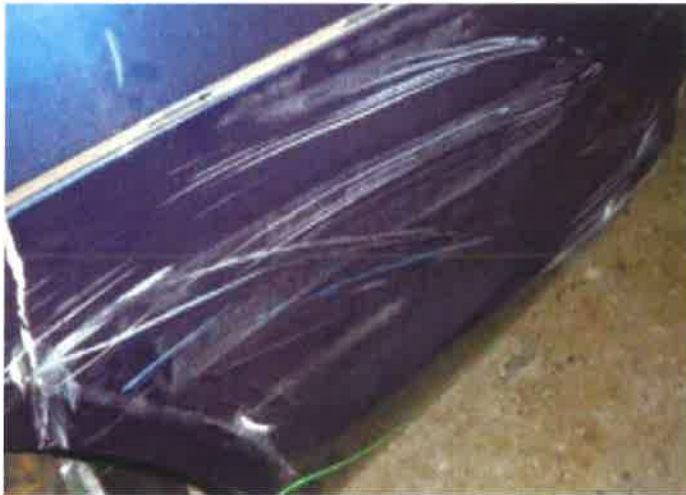
Figure 6: Photograph taken of the damages to the left (driver side) rear quarter panel.

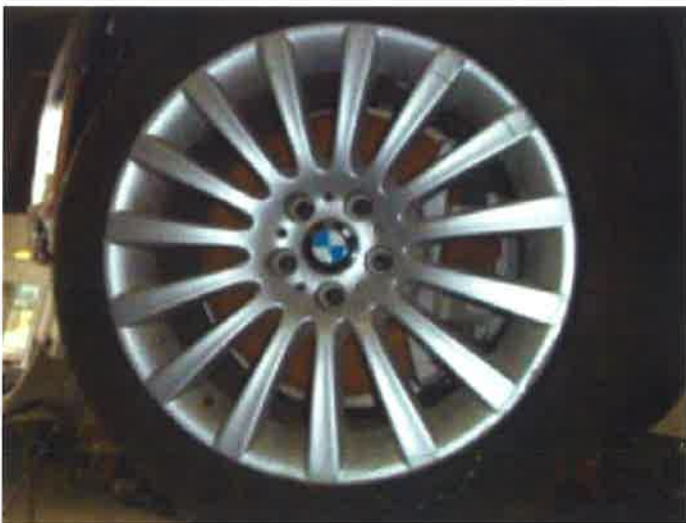
Figure 7: Front left (driver) side wheel cover.

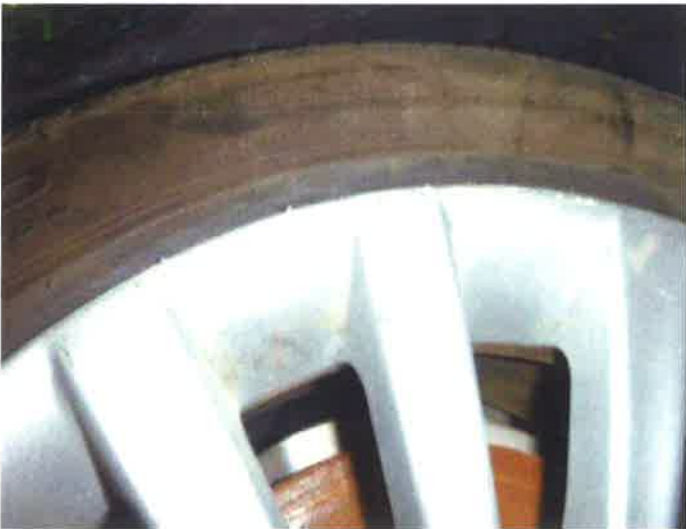
Figure 8: Close-up of the front left wheel cover. *Note:* There are no circumferential markings along the wheel cover to indicate the wheel was rotating at the time of impact.

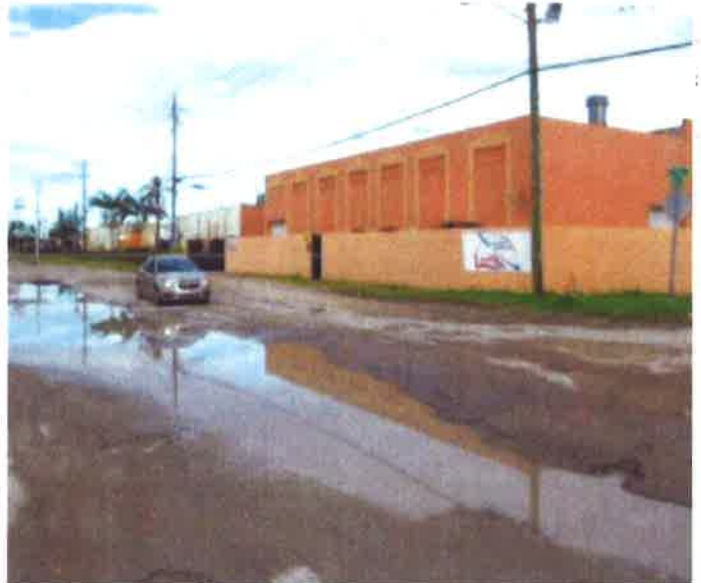
Figure 9: Photograph taken looking east on Access Road. *Note:* Area is depicted as being in an Industrial / Warehouse District.

Finally, there was severe damage to the undercarriage and main support components. This type of damage is not only inconsistent with a sideswipe, but also did not match the terrain of the accident site. In order to have severe damages to an undercarriage, a vehicle would have to be driven in an abusive manner over an uneven, irregular surface. In this case, it was not consistent with the terrain as shown in the photos of the site above.

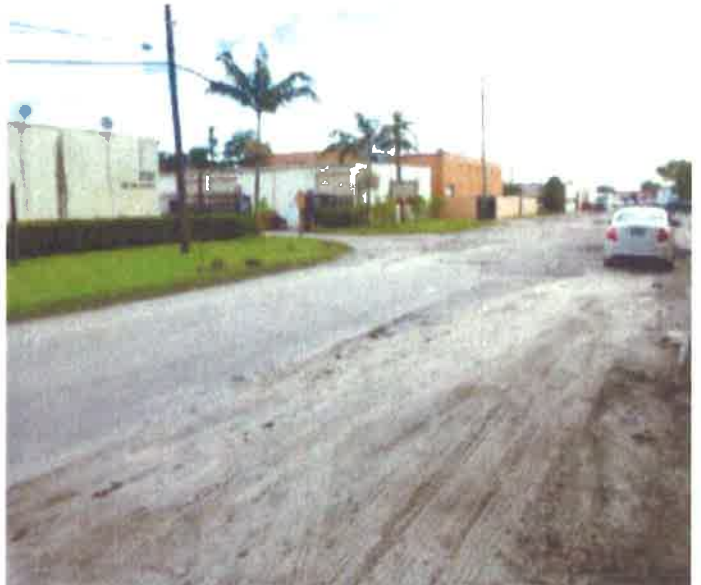
Figure 10: Photograph taken looking west on Access Road. *Note:* The reported direction of travel for the phantom hit and run vehicle. * Overall width of roadway, is approximately 26 ft. in width. There is no curbing or concrete culverts in the area.
