## Fire, Cause & Origin of Heavy Vehicles: Mechanical & Forensic Methods

FIRE INVESTIGATION

BY CHRISTOPHER W. FERRONE

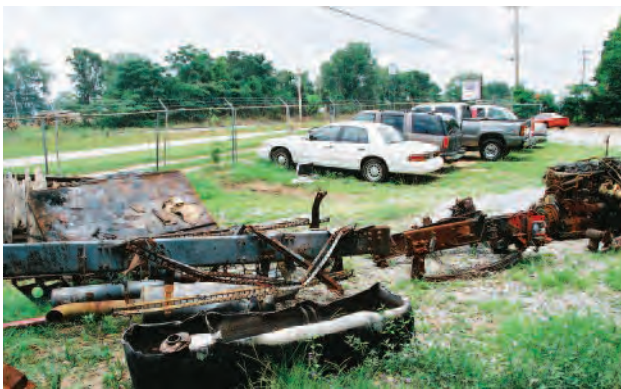
Photo 4:  
Reassembling  
components.

This analysis involves the observation of flame/heat damage patterns leading to the origin of the fire (Photo 3). The technique is generally comprised of the elements shown in the flowchart (Figure 3) and come from NFPA 921. This method is further facilitated by reassembling the truck (as much as possible) to show configuration and component placement (Photo 4).

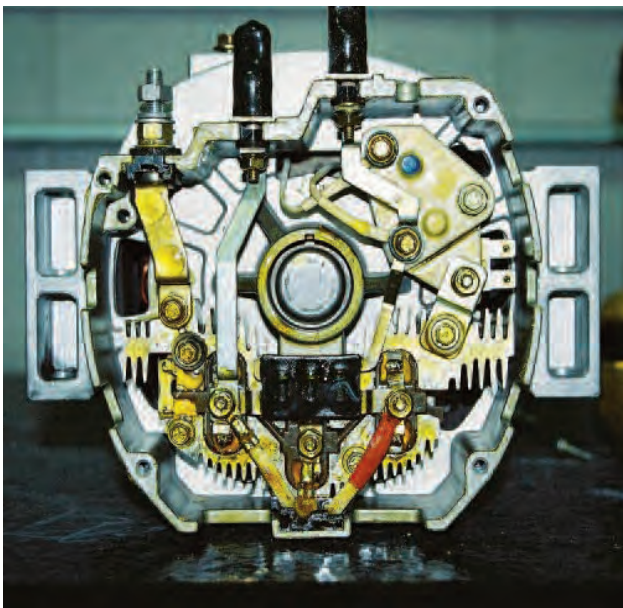
Photo 8: Artifact alternator.

In some instances, a fire has begun with the vehicle's engine off and after some period of time since the most recent engine shutdown. This can be attributed to an internal alternator failure, in some instances a diode failure. Diodes act as a one-way check valve for current. Typically, if a diode fails in this scenario, positive (B+) battery voltage/current goes to ground and has been known to start a fire (Photos 7, 8 and 9).

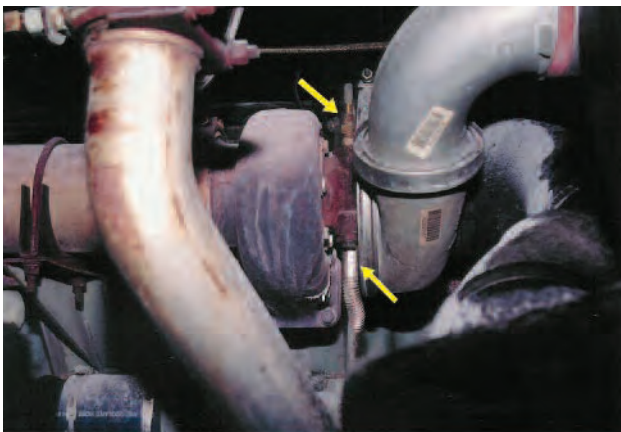
Photo 26: Turbocharger/waste gate.

from the waste gate pivot point can be observed (Photo 26). Once oil has begun to leak from this point on the turbocharger, it should be removed from service and the exhaust system should be thoroughly cleaned. To assist in preventing this failure mode, the turbocharger waste gate or variable geometry function (VGT) must be confirmed.
