**IMECE2006-13305**

**“FIRE AND EXPLOSION INVESTIGATIONS; WHY HEAVY TRUCKS MAY BURN”**

**Christopher W. Ferrone**  
ARCCA, Inc.  
550 W. Van Buren, #1220  
Chicago, IL 60607  
312.386.2300  
cferrone@arcca.com

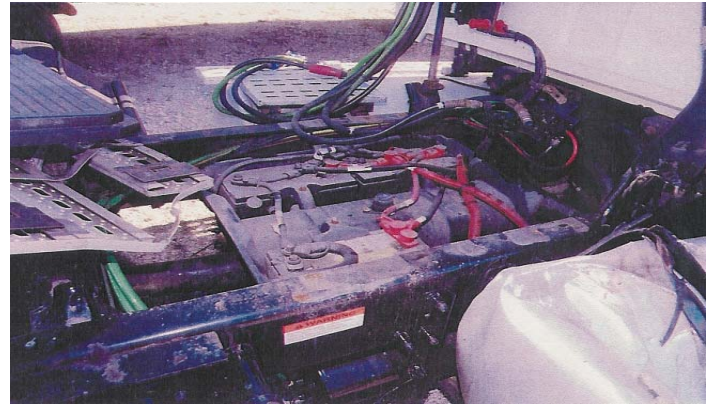
**Photo 16 – Sterling Truck/Tractor**

Since the alternative only proposes moving the battery box to inside the frame rails, in a nested orientation, there are no technical hurdles which would need to take place. Moving the batteries simply consists of fabricating steel brackets and forming a plastic/composite box to fit around the drive shaft. To further make this point, the author has inspected other brands of class 8 truck tractors with batteries inside the frame rails (Photo 16) (Appendix C).

Interestingly enough Sterling<sup>1</sup>, a division of Freightliner, has a model with the batteries located within the frame rails. This may not appear very impressive but the point to be taken away from this is this tractor appears to be generally the same as the original design by Ford Heavy Truck but with the Freightliner battery location/design. The initial implication of this is that this design can be employed into other truck tractors with minimal design efforts.

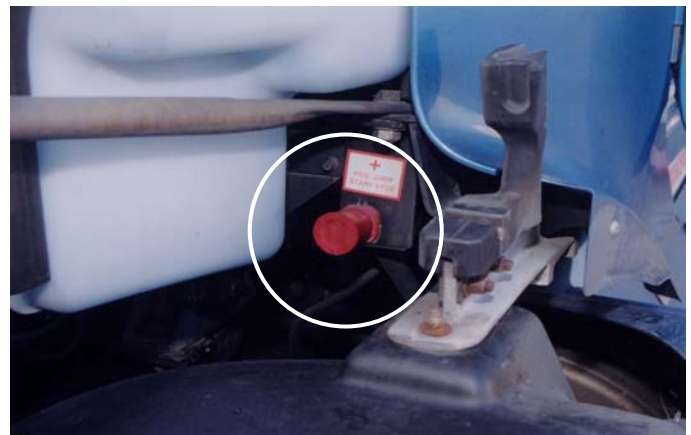
Photo 17 –Engine Compartment Jump Post

Moving the battery box to inside the frame rails will not create any operational problems or maintenance interference. Drivers typically do not interact with the batteries frequently. If the need to jump-start the truck arises, remote jump-posts (already in use) can be contemplated for installation in a safe location (Photo 17). As for maintenance, the

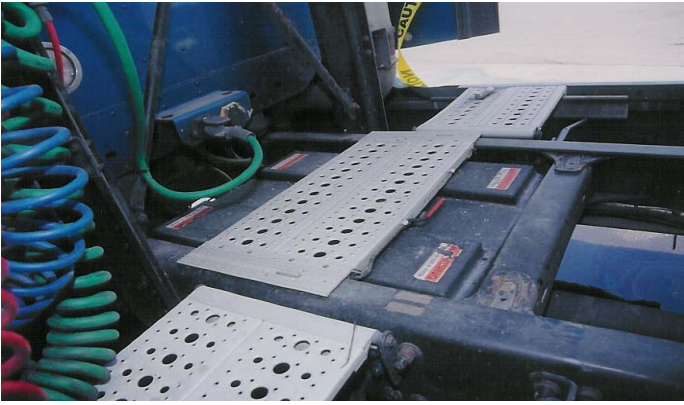
**Photo 18 – Battery Access Covers, Freightliner Century Class**

current location on a typical truck tractor requires work by the mechanic to remove the fiberglass fering to access the batteries. The Freightliner design has immediate access by removing an expanded metal "cat-walk" (Photo 18). In the unlikely event the Freightliner design was too difficult for a mechanic, one would think that:

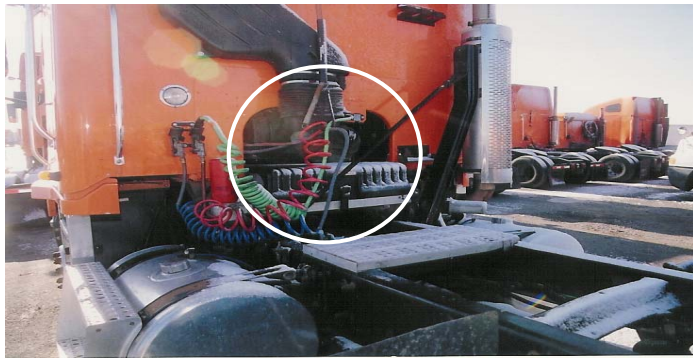
**Photo 19 – Freightliner C.O.E**

- If the truck tractor is C.O.E. configured the batteries may be located symmetrically on top of the frame rails (Photo 19 & 20).
