IMECE 2009-10522

**FIRE, CAUSE AND ORIGIN OF HEAVY VEHICLES
(MECHANICAL AND FORENSIC METHODS)**

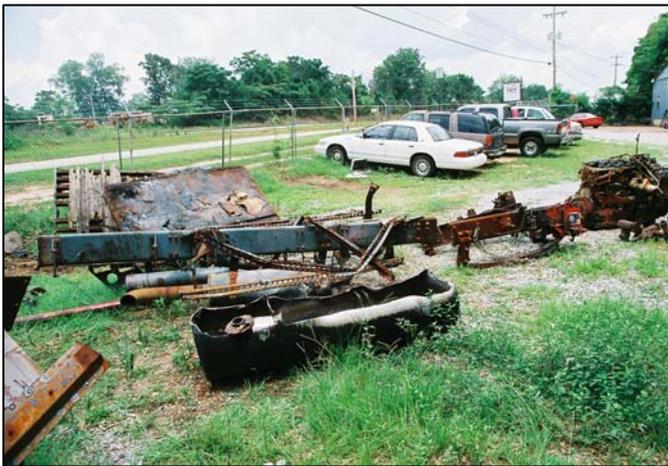
Photo 2B: Reassembling components

This analysis involves the observation of flame/heat damage patterns leading to the origin of the fire (Photo 2A). The technique is generally comprised of the elements shown in the flow chart (Appendix A) and come from N.F.P.A. 921. This method is further facilitated by reassembling the truck (as much as possible) to show configuration and component placement (Photo 2B).

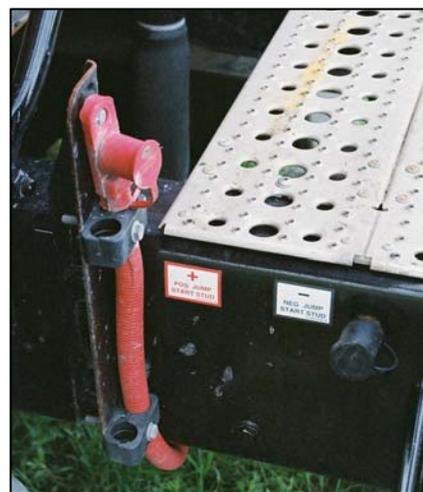
Photo 5A: Remote Jump Posts

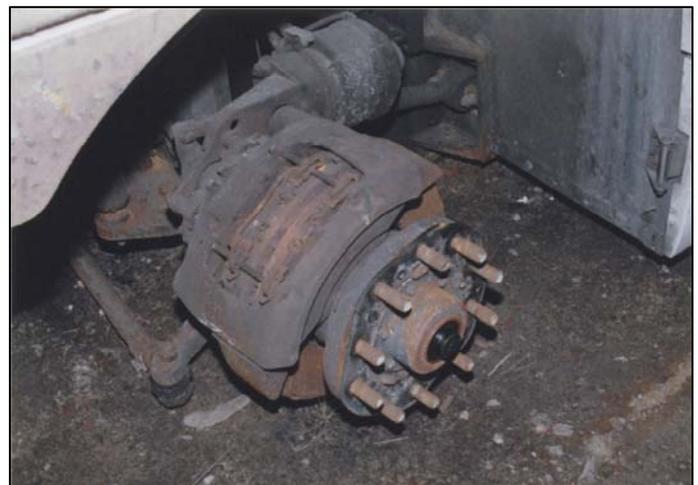
Photo 9: Non-Causal Disc Brake/Wheel End

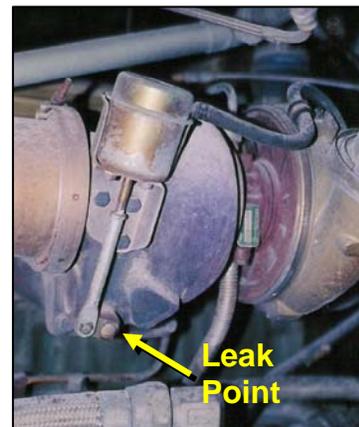
Photo 17: Turbocharger/Waste Gate

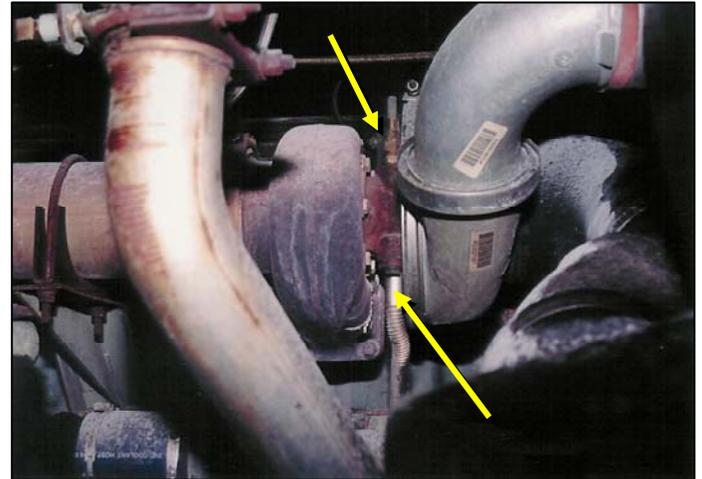
Photo 18: Typical Turbocharger Oil Inlet/Outlet Lines

With most 4-stroke cycle inline engine applications, the turbocharger has two oil lines which need to be periodically inspected (Photo 18). These turbochargers have an external supply and return oil line. In either case, a leaking oil line must be repaired to prevent an auto-ignition fire.

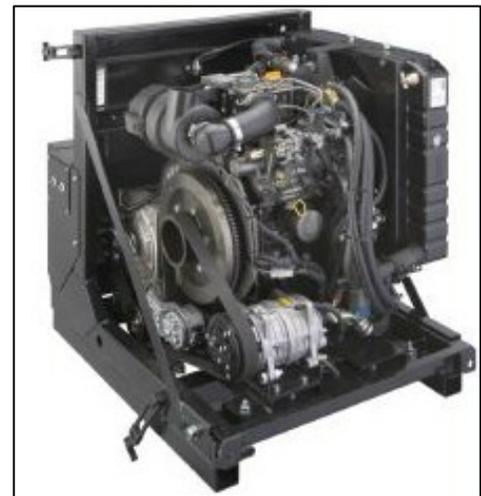
Photo 19: Auxiliary Power Unit

Some heavy trucks utilize an auxiliary power unit to provide air conditioning, heat or electrical power while the engine is off (Photo 19). These need to be inspected and analyzed to determine if they are related to the fire. The A.P.U. is similar to the trucks engine in that it has its own starter, alternator, fuel system, lubrication and electrical distribution system. Each of these items needs to be analyzed to determine if any were related to the fire. Additionally, the A.P.U. can also be an auto-ignition concern and must be evaluated in that regard.

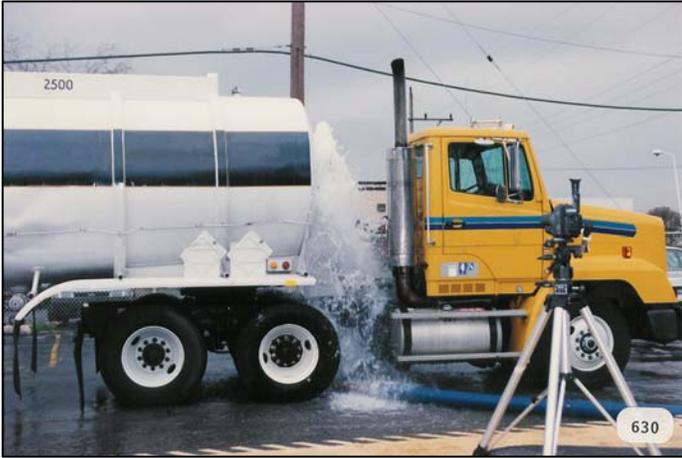
Photo 23: Full Scale Testing of Fuel Breach

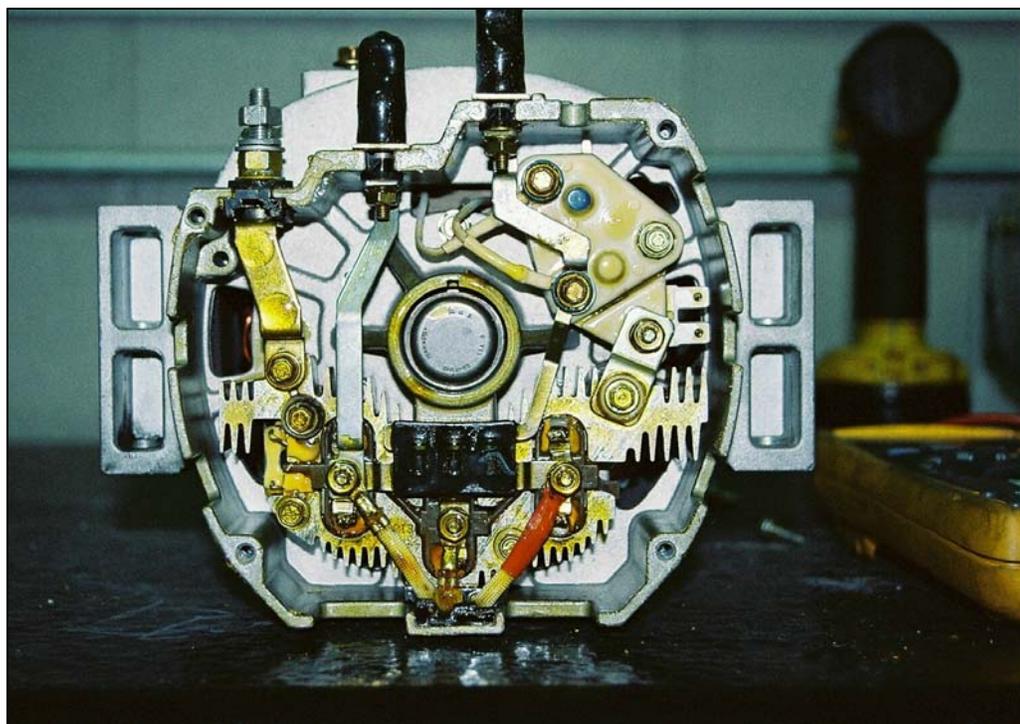
Exemplar Alternator

In some instances a fire has begun with the vehicles' engine off and after some period of time since the most recent engine shut-down. This can be attributed to an internal alternator failure; in some instances a diode failure. Diodes act as a one-way check valve for current. Typically, if a diode fails in this scenario, positive (B+) battery voltage/current goes to ground and has been known to start a fire (Photos 4A and Appendix B).
