# INVESTIGATING CARBON BICYCLE ACCIDENTS

Was It a Defect or Something Else?

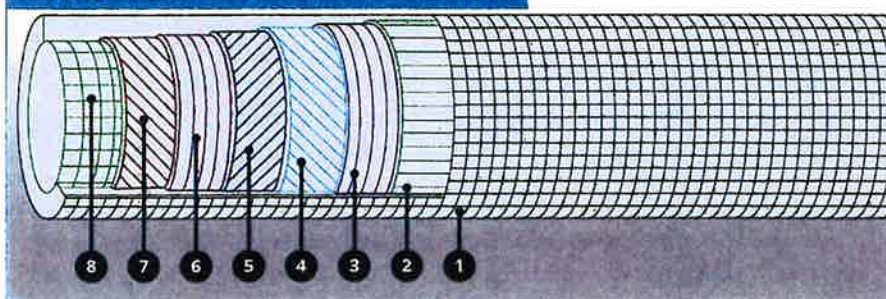
FIGURE ONE: EXAMPLE OF A TUBE LAYUP.

Generally, the carbon fiber used comes in rolls of thin sheets of uncured epoxy resin that is pre-impregnated with long, continuous fibers (prepreg). How much resin is present, and what type it is, depends on the grade and end use of the carbon fiber prepreg. These are then added together in layers to form the preliminary part. To give the manufactured component good properties in multiple directions, the angle of the fibers is alternated or varied in each layer. This process is called the "layup" step, and the angle of the fibers in each layer is often listed as the "layup orientation." See figure one for more detail.
